### Captains Bay Road Waterline EXHIBIT 01

### **GEOTECHNICAL REPORT**

Captains Bay Road Unalaska, Alaska

September 2018

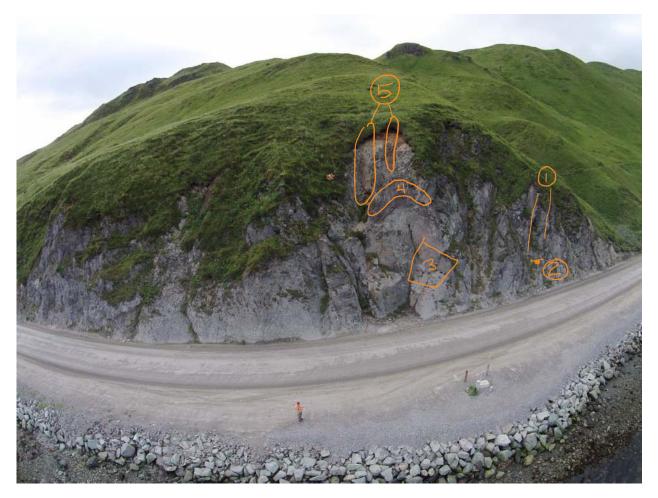
Photo 1. Wide angle view of Area 1.

- 1. Subvertical fracture planes in this area. The planes are spaced approximately 2 feet to 4 feet apart. The rock weathers into overhanging blocks.
- 2. Fracture plane orientated at N80E, 70°N
- 3. Fracture planes orientated at N5E, 39°W
- 4. Approximately 3 foot thick band of what appeared to be highly folded or metamorphosed rock.
- 5. Area between rock columns appears to be weathering more quickly.

East of the areas noted above, the rock appeared to have fewer fractures and be more competent.

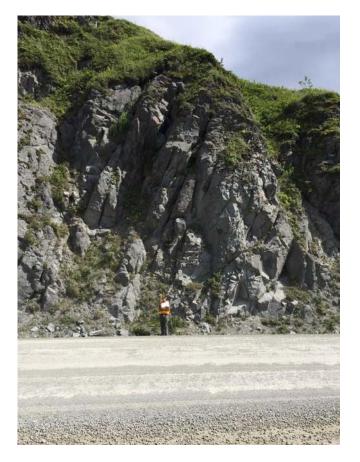
Photo 2 (Left). Photo of the fracture planes identified in Photo 1, Note 1.

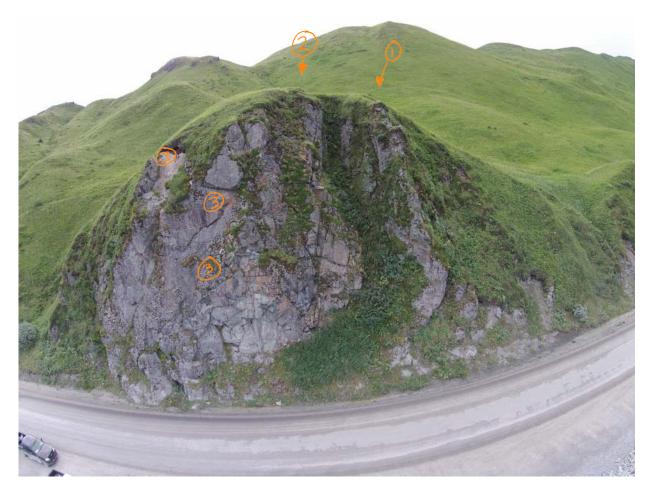
Photo 3. Wide angle view of Area 2.

- 1. Narrow spire of rock.
- 2. Spire of rock, wider than the spire indicated by Note 1.
- 3. Fracture planes in many locations (more than highlighted), that are adversely orientated toward the roadway.

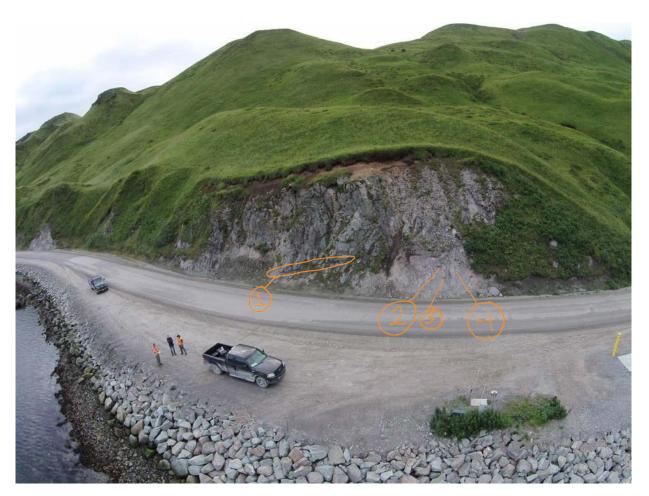
Photo 4. Wide angle view of Area 3.

- 1. Sub-horizontal fracture plane that appeared to be dipping 15 degrees toward the east.
- 2. Fracture plane orientated at N55W,  $40^{\circ}$ S
- 3. Fracture plane orientated at N18W, 60°S
- 4. Fracture plane orientated at N41E, 61°N

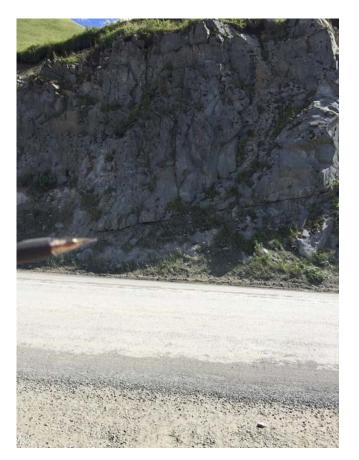
Photo 5 (left). Sub-horizontal plane identified in Photo 4, Note 1.

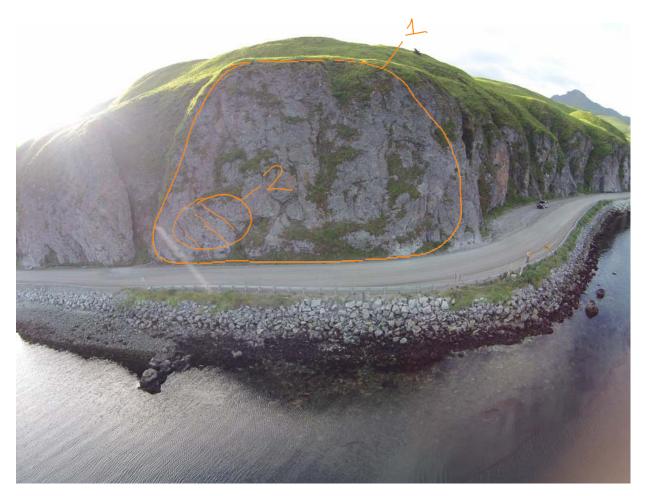
Photo 6. Eastern portion of rock outcrop along Area 4 (Deadman's Curve).

- 1. The rock along the eastern portion of Deadman's Curve appeared to be more massive with generally fewer fractures then other outcrops. Observed fractures were not adversely orientated.
- 2. Fractures noted that appeared to dip back into the face of the rock.

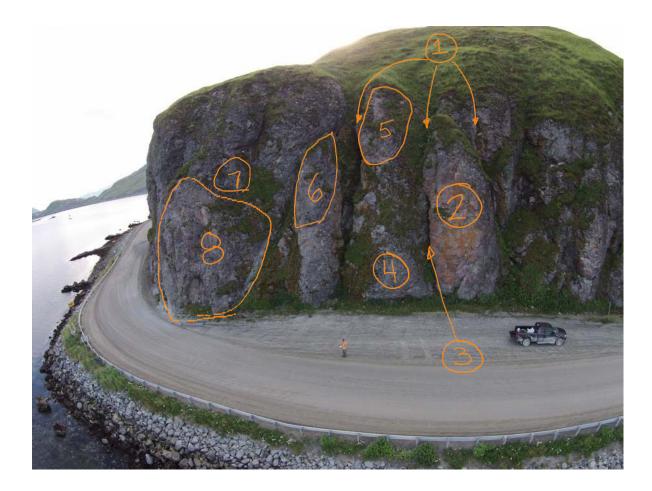
Photo 7. Western portion of Area 4 (Deadman's Curve).

- 1. Series of vertical fracture planes spaced approximately 15 feet to 20 feet apart.
- 2. Rock generally appears to be massive with limited adverse fracturing. Spalling of the rock was observed.
- 3. Vertical fracture plane orientated at approximately N55E.
- 4. Sub-horizontal bedding planes 2 inches to 12 inches thick. Fractures orientated at N60E, 27°S
- 5. Large, overhung block created by fracture planes.
- 6. Large, overhung block created by fracture planes.
- 7. Large, overhung block created by fracture planes.
- 8. Rock generally appears to be massive with limited adverse fracturing.

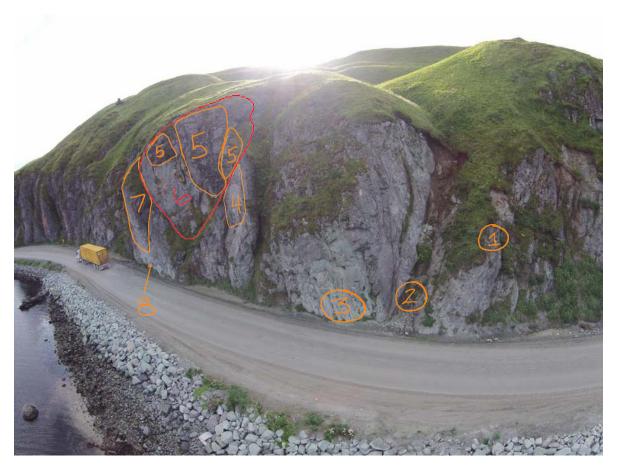
Photo 8. Wide angle view of Area 5.

- 1. Rock has fewer fractures in this area. Appears to weather into blocks that are overhanging.
- 2. Water seeping out of the base of the crevasse.
- 3. Fractures spaced as closely as 4 inches and orientated at N37W, 65°S.
- 4. Overhung block with adverse fractures in back of block.
- 5. Three overhung blocks with adverse fractures in back of the blocks.
- 6. Large section of rock defined by two adverse fracture planes.
- 7. Overhung block with adverse fractures in back of block.
- 8. Signs of more severe weathering at base.

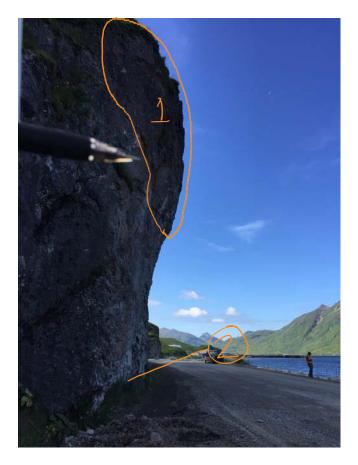
Photo 9 (Left). Looking southwest at a portion of Area 5.

- 1. Overhung block identified in Photo 8, Note 7.
- 2. Weathering identified in Photo 8, Note 8.

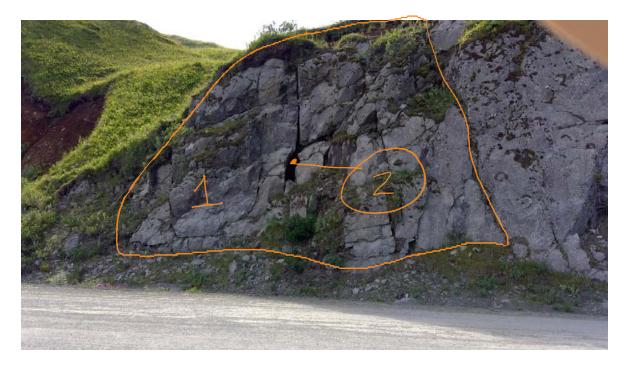
Photo 10. View of the northeastern portion of Area 6.

- 1. Area very fractured
- 2. Large opening observed.

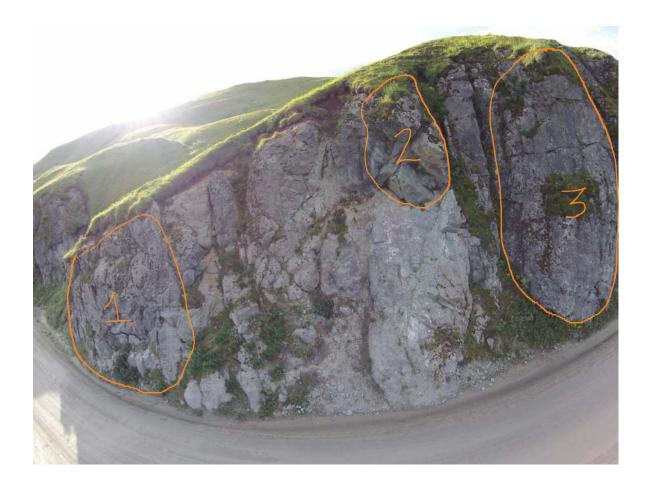
### Photo 11. Central portion of Area 6.

- 1. Rock is very fractured. Some fractures are oriented adversely.
- 2. Overhung blocks with adverse fractures along back of blocks.
- 3. Rock is generally more massive in this area but faster weathering at base leaves rocks above overhanging.

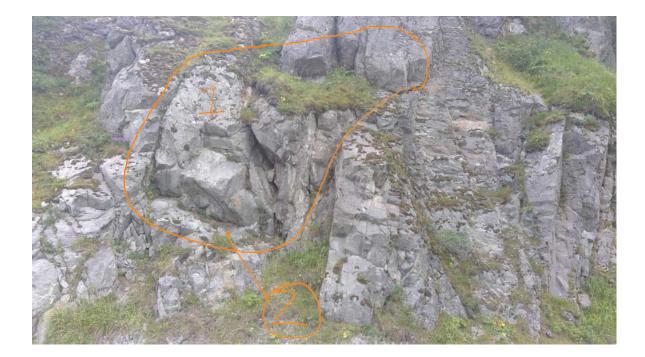
Photo 12. Central portion of Area 6, southwest of the portion shown in Photo 11.

- 1. Fractures create a blocky structure through this area; adversely orientated fractures noted.
- 2. Fractures orientated at N10W, 35°S.

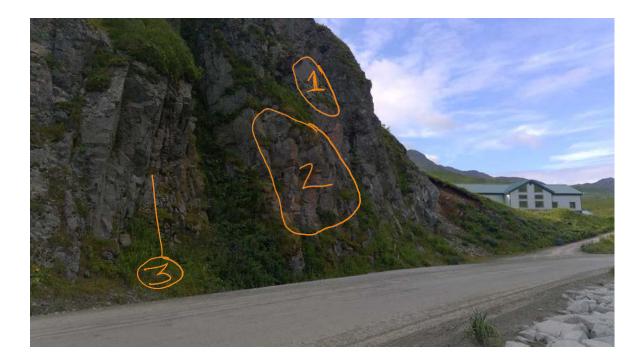
Photo 13. Southwestern portion of Area 6.

- 1. Adversely oriented fracture plane.
- 2. Overhung rocks with adverse orientation of the fracture planes.
- 3. Zone with nearly vertical fractures (N40W, 78°N) resulting in overhung blocks from layers that are 8 inches to 18 inches thick.
