Final Groundwater Monitoring Report

Amaknak Pre-WWII Tank Farm Formerly Used Defense Site

Unalaska, Alaska

February 2013

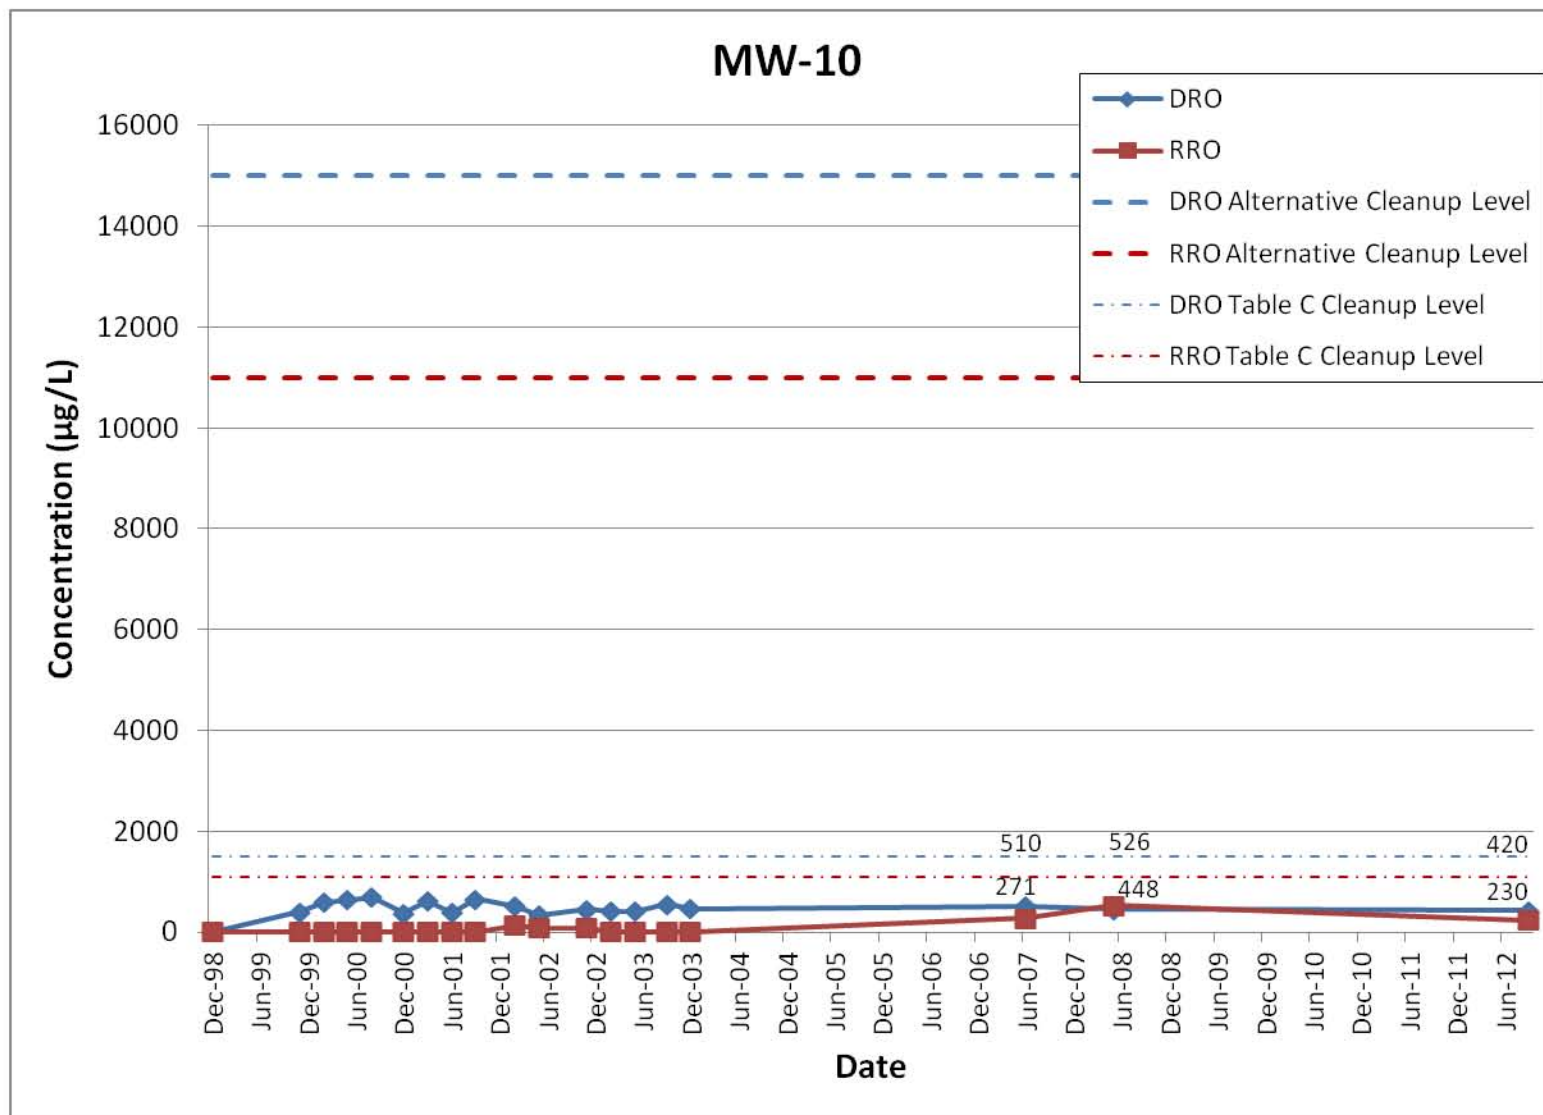
Graph A-5 MW-10 Petroleum Hydrocarbon Concentrations Over Time

Notes – Historical non-detect results are assumed to be zero for graphing purposes

For clarity, only numerical results from the last three sampling events are shown

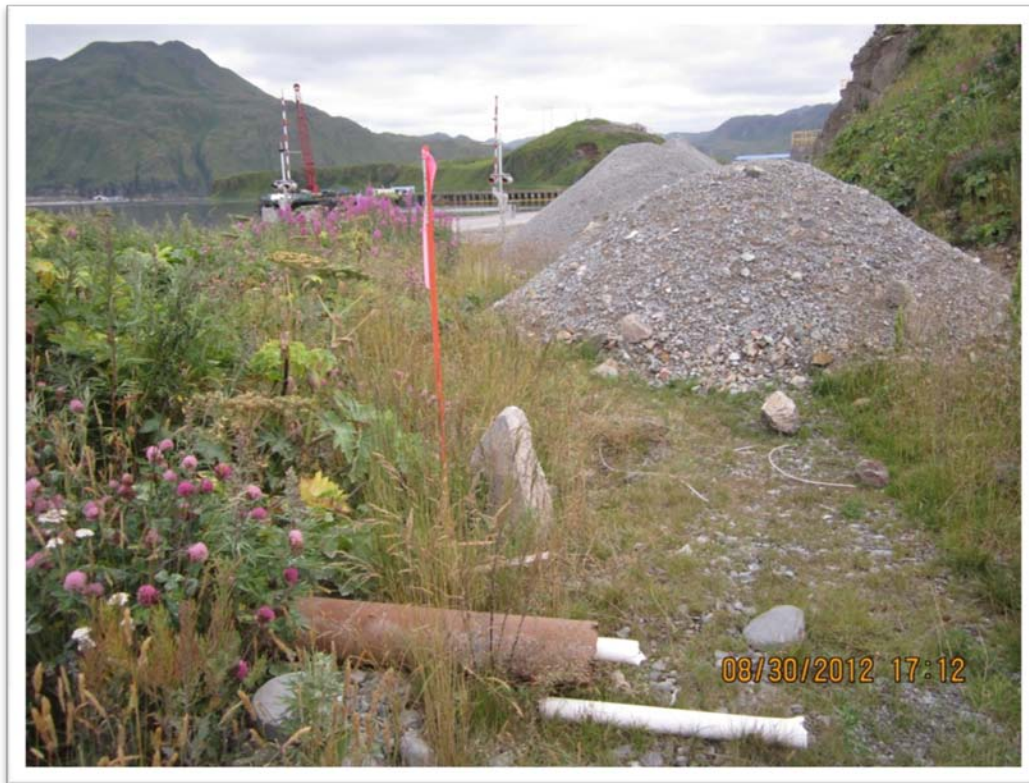
Photograph 1 – Well MW-1 was destroyed. View to the southeast.

MW-1 was located but had been destroyed. The well had been completed as a stickup; aboveground portions of the well, including the well casing and protective bollards were found lying on the ground (see photographs in Appendix F). No water level was recorded from the well as planned. The monitoring well and protective bollards were not removed by USACE or with the

knowledge of USACE. Proper decommissioning of the well is recommended. The party responsible for decommissioning this well has not yet been identified. MW-1 was located outside the Pre-WWII tank farm aquifer and its loss does not significantly affect the long term monitoring.

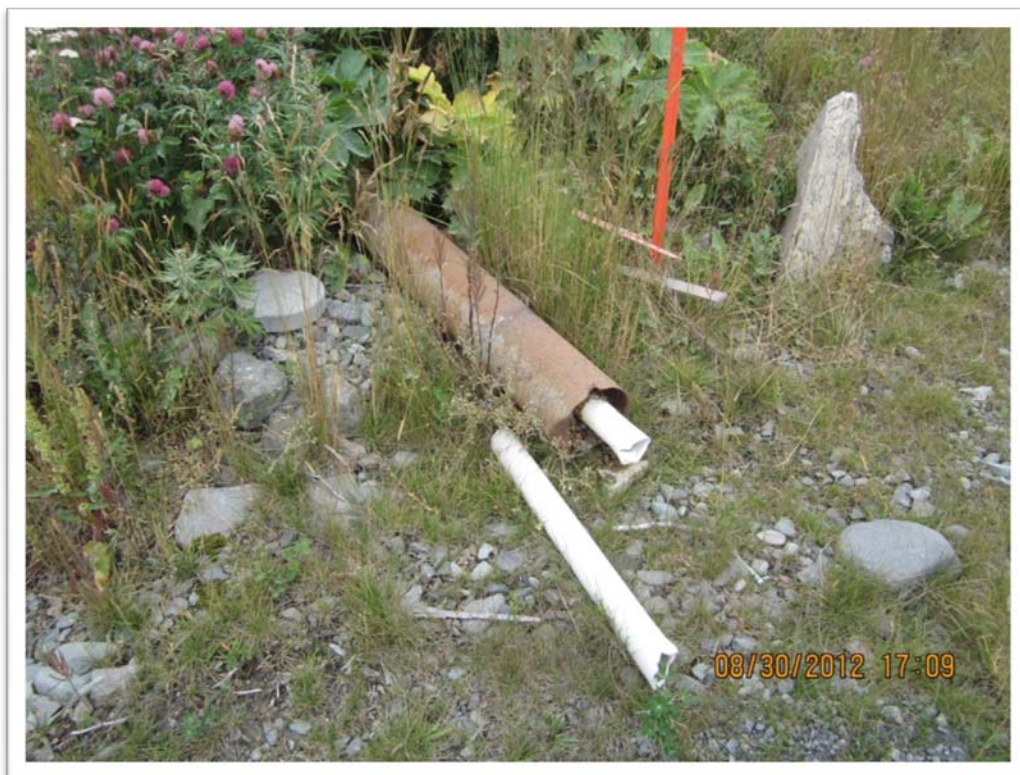
Photograph 2 – Well casing and monument for destroyed MW-1.

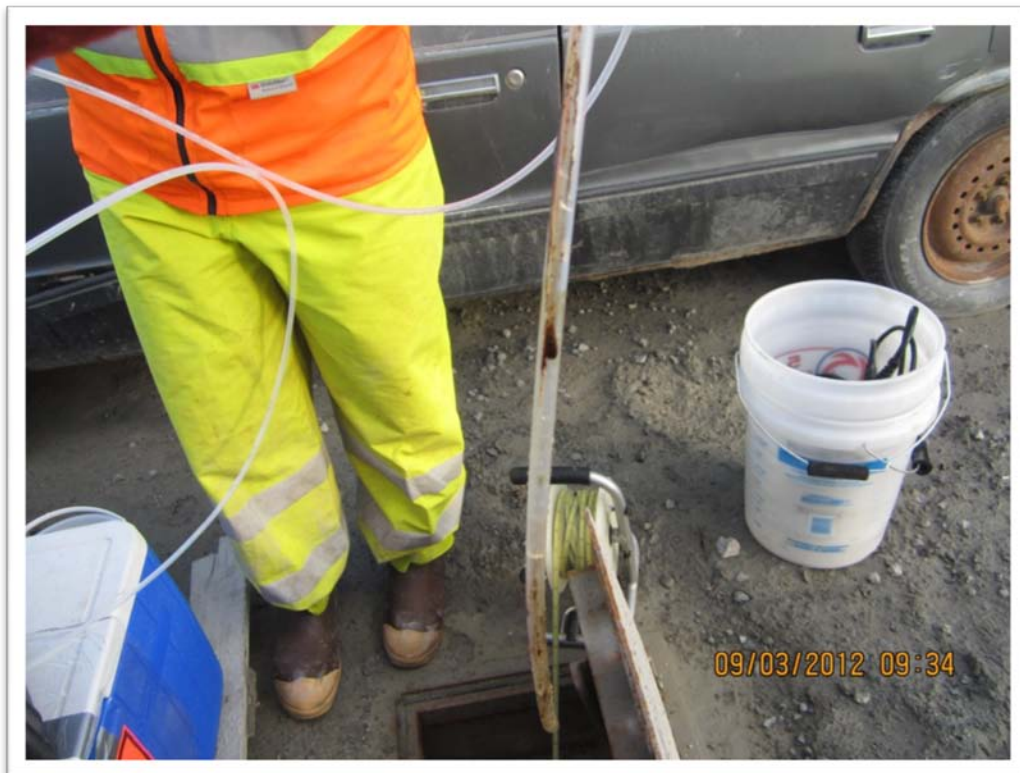
Photograph 4 – Product on tubing at MW-2 during purging; well was not sampled. View to the north.

Product was not detected with an oil/water interface probe in MW-2 and MW-17, but product was noted inside the disposable sampling tubing during purging (see photographs Appendix F). Sheen was also noted in the purge bucket.

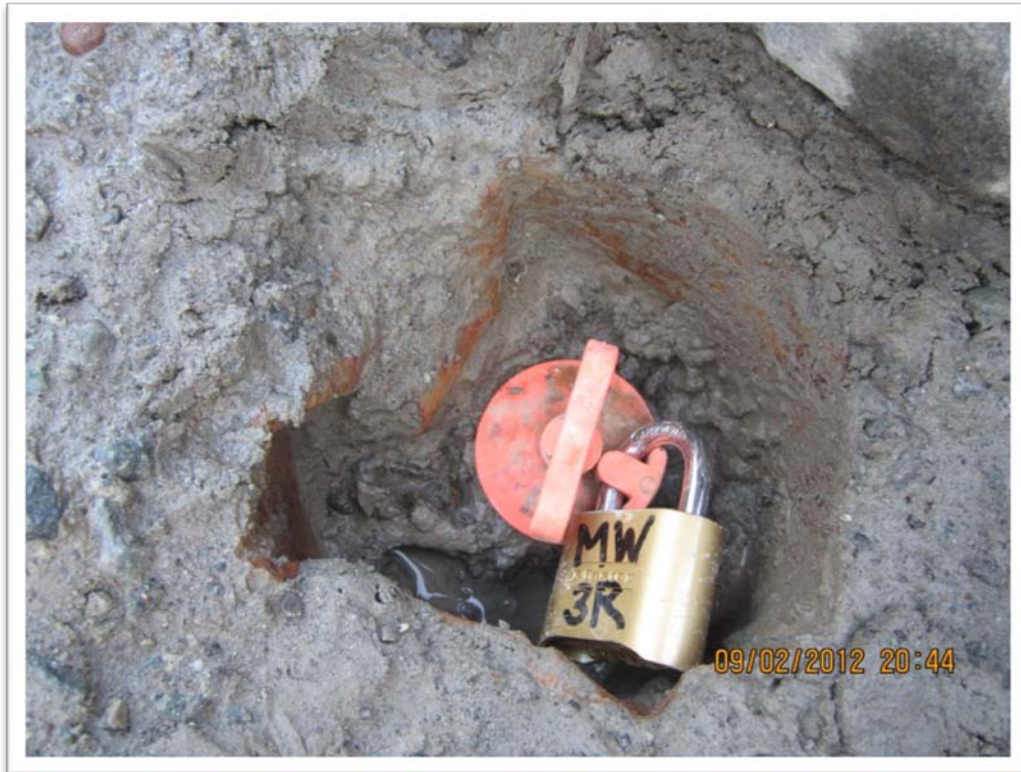
Photograph 5 – Close up shot of MW-3R, well is in poor condition with broken monument.

Subcontractors for Chevron periodically sample monitoring wells MW-3R and MW-15. A semiannual sampling event was scheduled for November 2012. The project manager stated that they did not have time to repair MW-3R during the field visit, but would try to repair the well next year (Lucyk, 2012).

- Surface water was entering monitoring well MW-3R during time of sample collection due to lack of a well monument, well casing below grade, and heavy precipitation at the time of sampling. As a result, the results for sample 1209A3R1WG were qualified (QN) as estimates due to potential lack of groundwater sample integrity. Although laboratory results were generally lower than historical results indicating sample dilution, sheen was noted in parking area surrounding the well. Consequently, impact to data quality and potential bias is unknown.

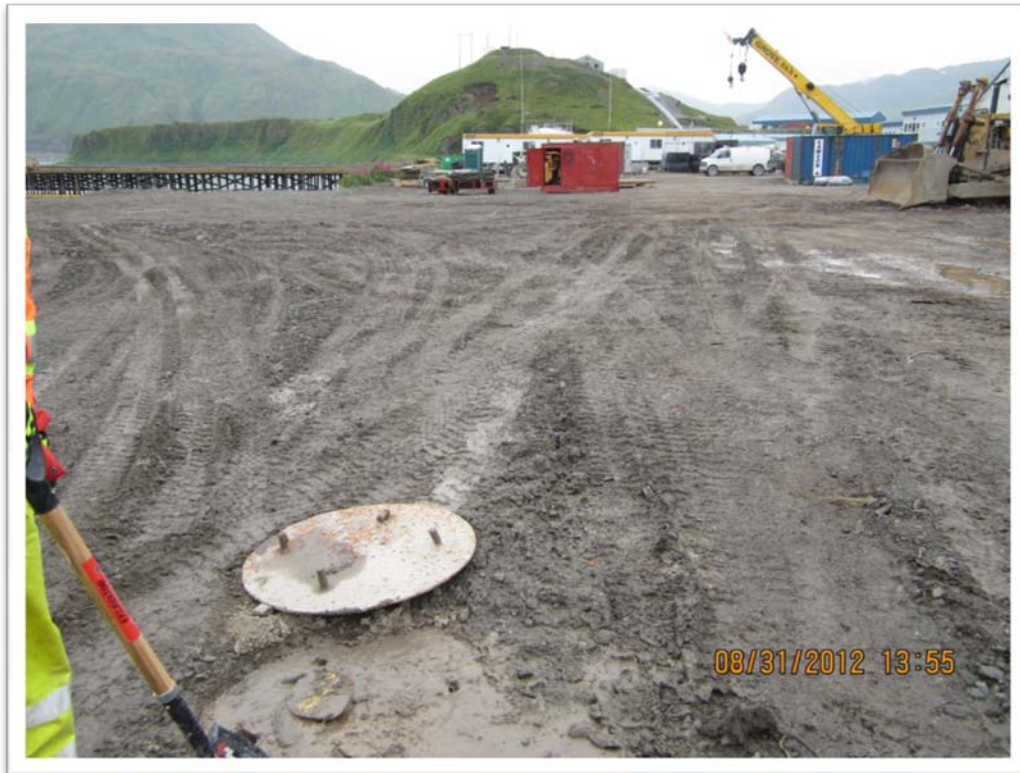
Photograph 15 – Locating well MW-11; this well was previously a stick-up, but was cut down to a flushmount during construction activities. View to the south.

Several wells were found to be in poor condition, with broken or missing monuments and caps. Wells have been damaged or destroyed due to heavy machinery used in the storage yard and/or repeated contact with graders or snowplows. In particular, wells MW-3R, MW-11, MW-17, and MW-18 were in particularly poor condition. Sometime between the 2009 and 2012 sampling events, MW-11 had been poorly converted from a stick up to a flush mount well.

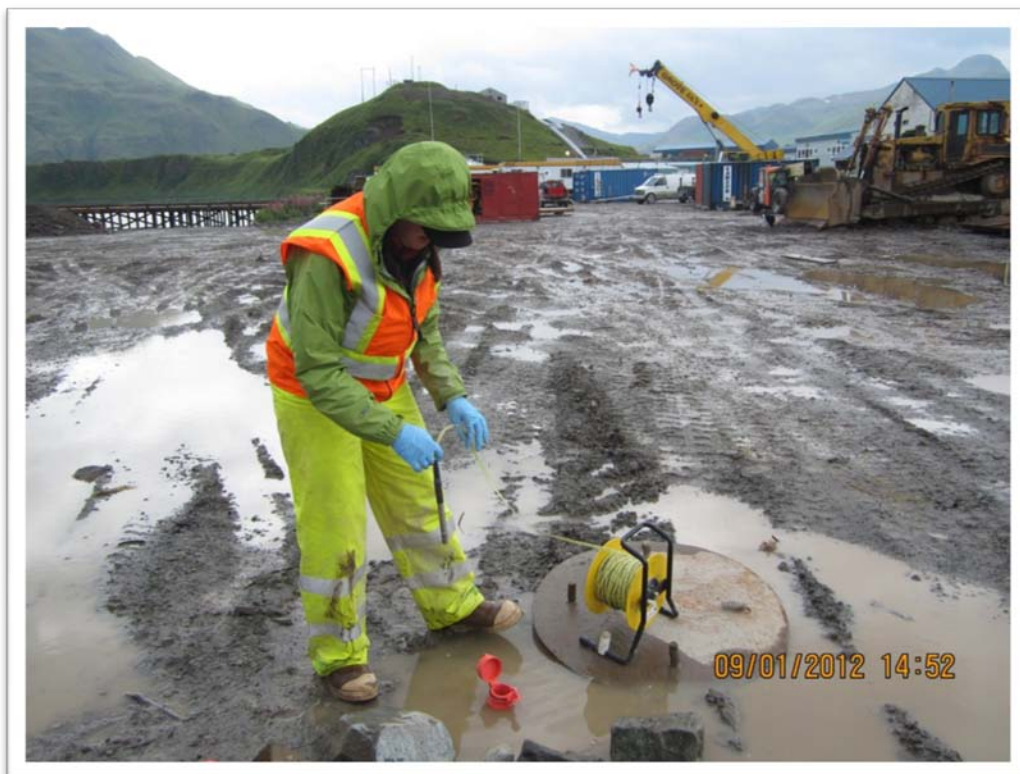
Photograph 16 – Collecting a water level measurement at well MW-11. A tall cap was installed over well due to surface water ponding, when survey was conducted for this well the elevation measured was to the top of the cap.

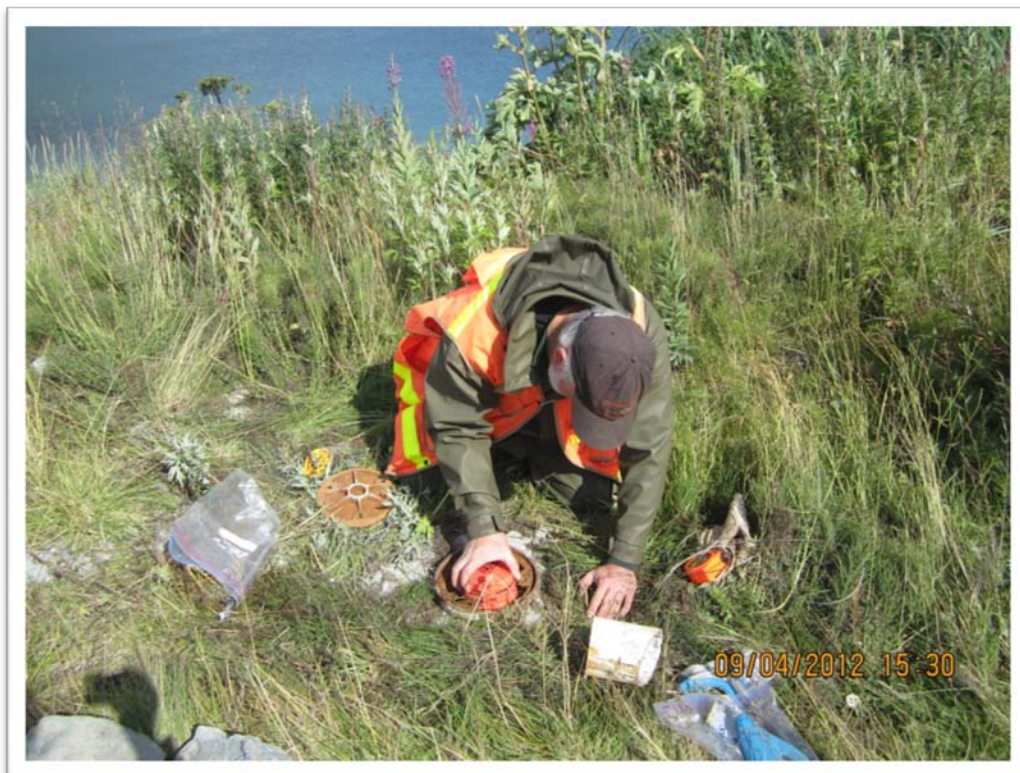
Photograph 18 – Installing transducer and locking cap on well MW-15, piece of PVC cut to accommodate locking cap is visible in center of photograph. View to the east.

While on site, the field crew replaced some wells caps and monument bolts/gaskets. In addition, MW-15 was cut down to accommodate a locking well cap equipped with a transducer. The survey was conducted after MW-15 had been cut down.

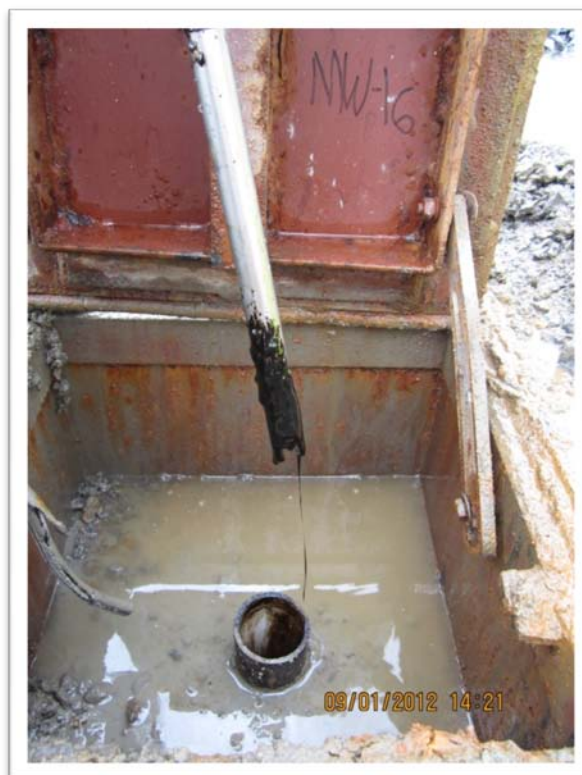
Photograph 20 – Discovering product while attempting to measure water level at MW-16N. Product was detected at approximately 6.55 feet (with a thickness of 0.01 feet) and again at 15 feet near the bottom of the water column (total depth in well was 16 feet).

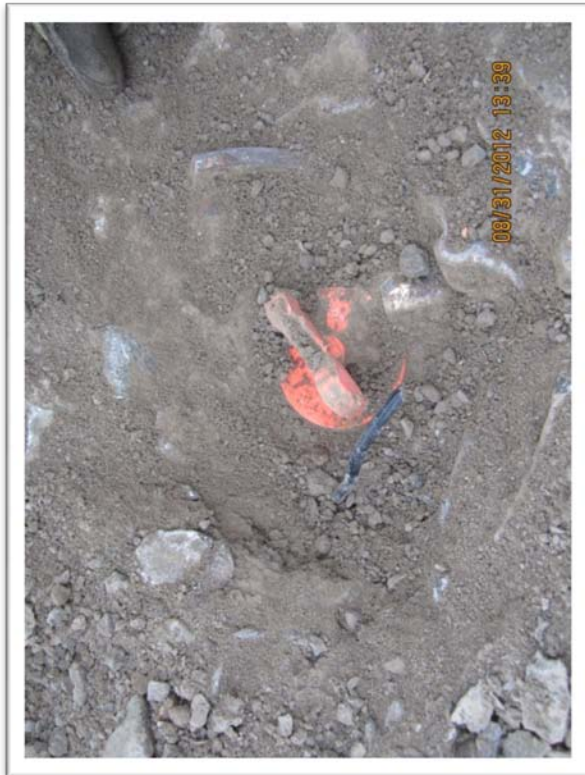
Photograph 22 – Condition of well MW-17, monument broken during construction activities.

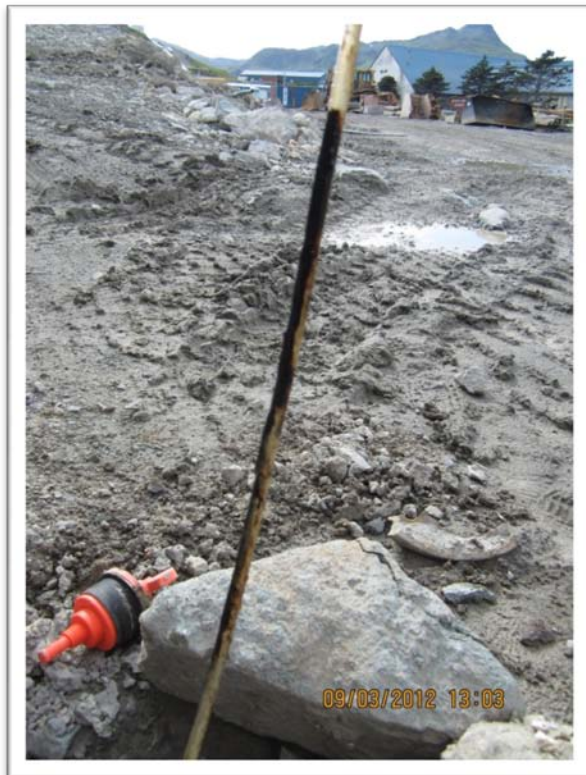
Photograph 23 – Product located on tubing in MW-17 during purging; did not sample well. View to the south.

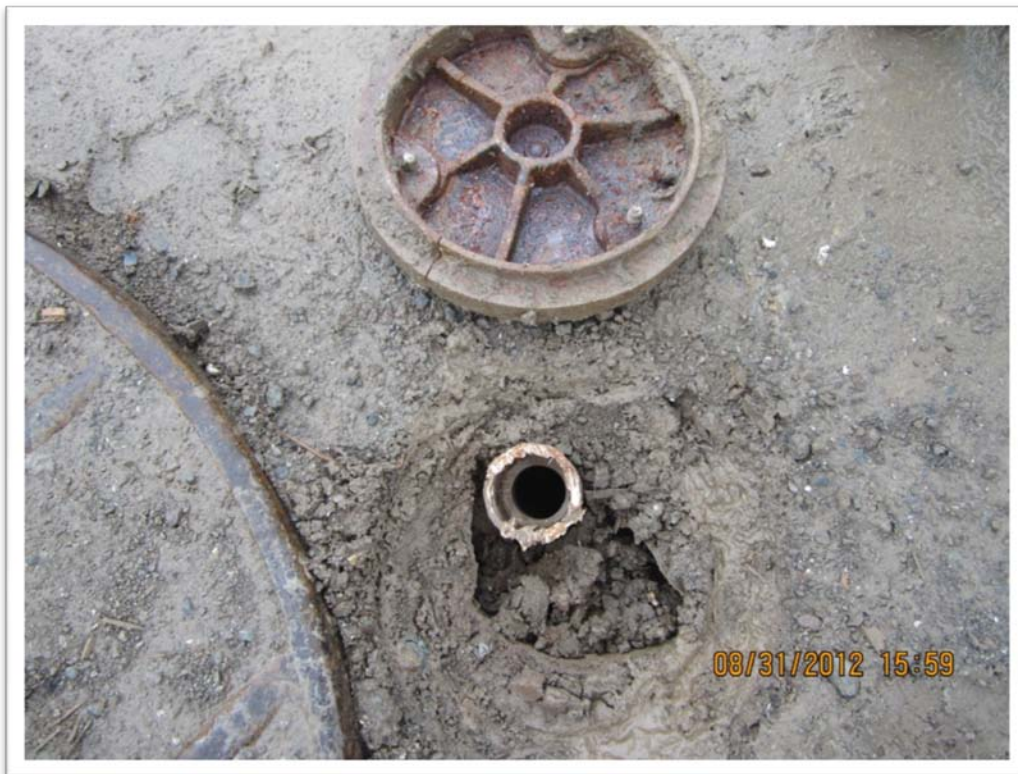
Photograph 25 – MW-18 had no cap and a destroyed monument. .

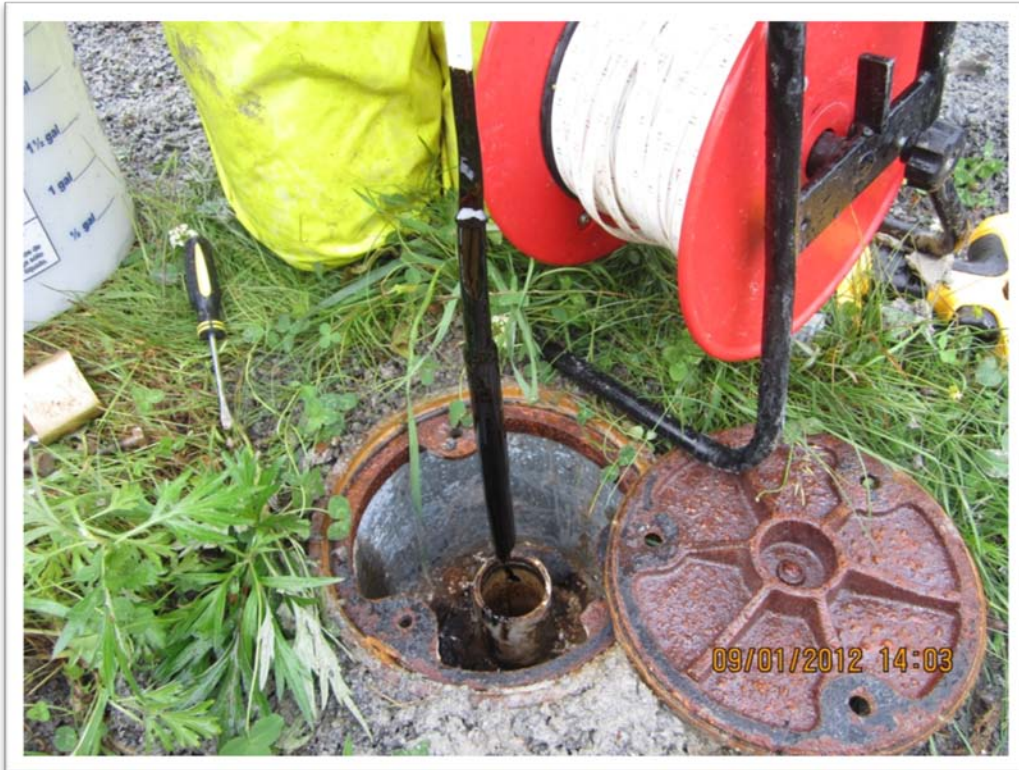
Photograph 27 – Water level could not be obtained in MW-19 due to viscous product completely coating the probe. Depth to product was measured at approximately 12 feet.

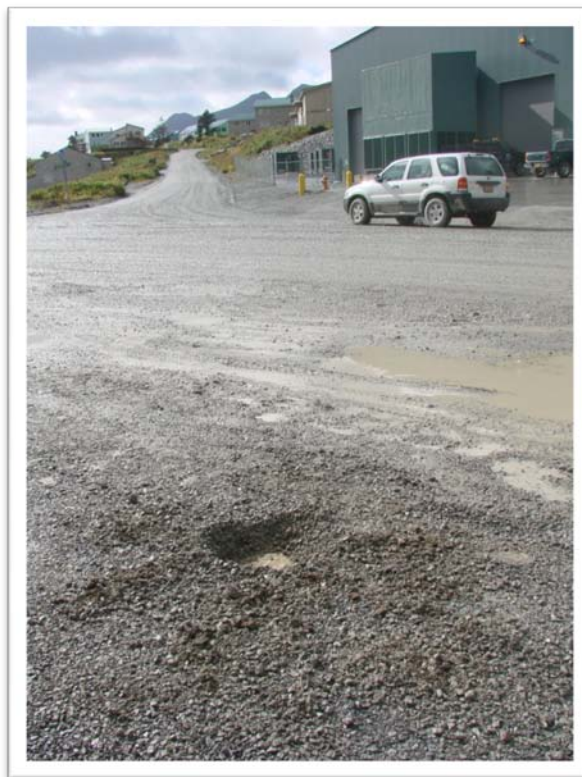
Photograph 31 – Well MW-23, presumed destroyed but discovered by a city employee following completion of field work. View to the west.

Five wells (MW-4R, MW-5, MW-12, MW-20, and MW-23) could not be located. One of these wells, MW-23, was presumed to be destroyed as construction crews reportedly destroyed a well during installation of a fuel line in the area (Hunter, 2012). However, a city employee later discovered the well and reported that it appears to be good condition (Lund, 2012). During the field investigation, a water sample was taken from nearby MW-10, as MW-23 had been presumed destroyed.
