Unalaska Aquatics Center

NATORIUM 121

(ATTACHMENT 2E)

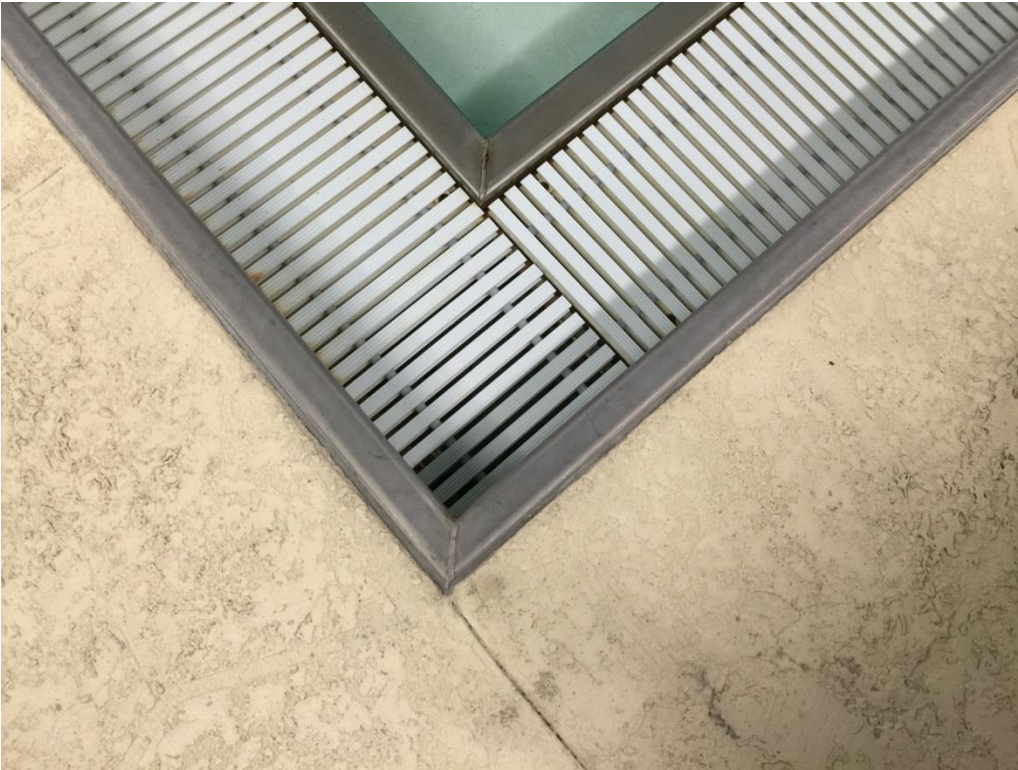
EXISTING DECKING MATERIAL INTERFACE
WITH GUTTER, TYPICAL CONDITION
IMAGE 5.

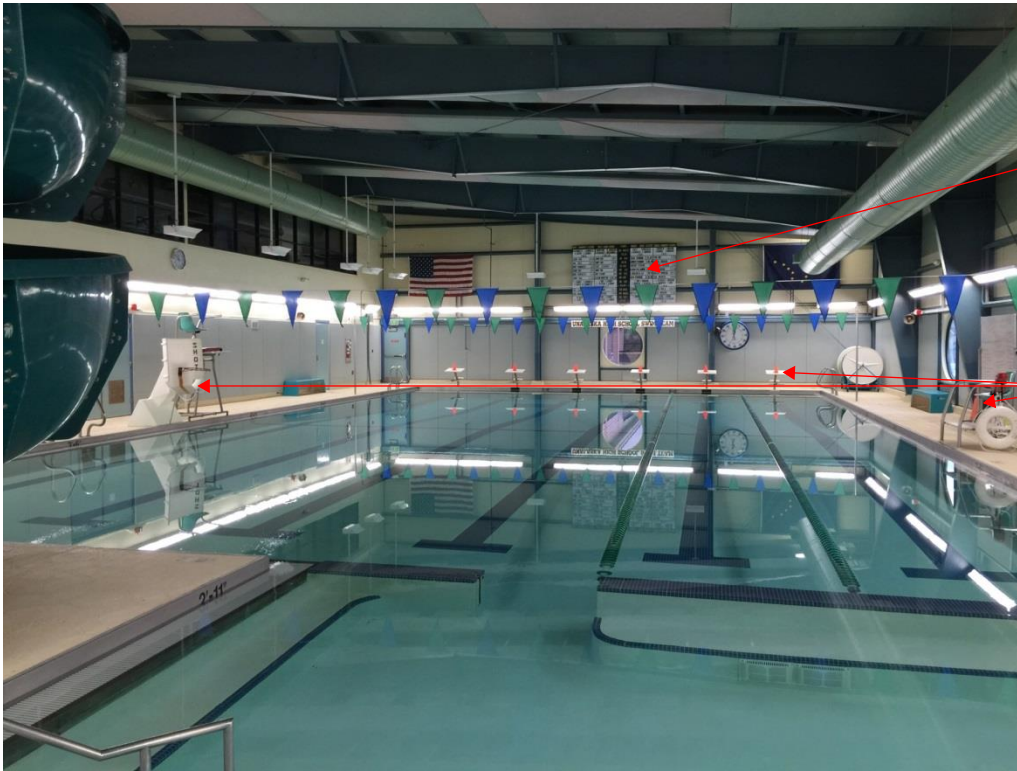
VIEW OF NATATORIUM LOOKING EAST
IMAGE 6.

REMOVE EXISTING WALL
MOUNTED BOARD. INSTALL NEW
TIMER BOARD IN THIS LOCATION

REMOVE ALL LADDERS,
LIFEGUARD CHAIRS, DRAINS,
STARTING BLOCKS, AND
OTHER PENETRATIONS AS
REQUIRED TO INSTALL NEW
DECK, (ALT 5) - REINSTALL
EXISTING ITEMS AFTER
DECKING INSTALL IS
COMPLETE

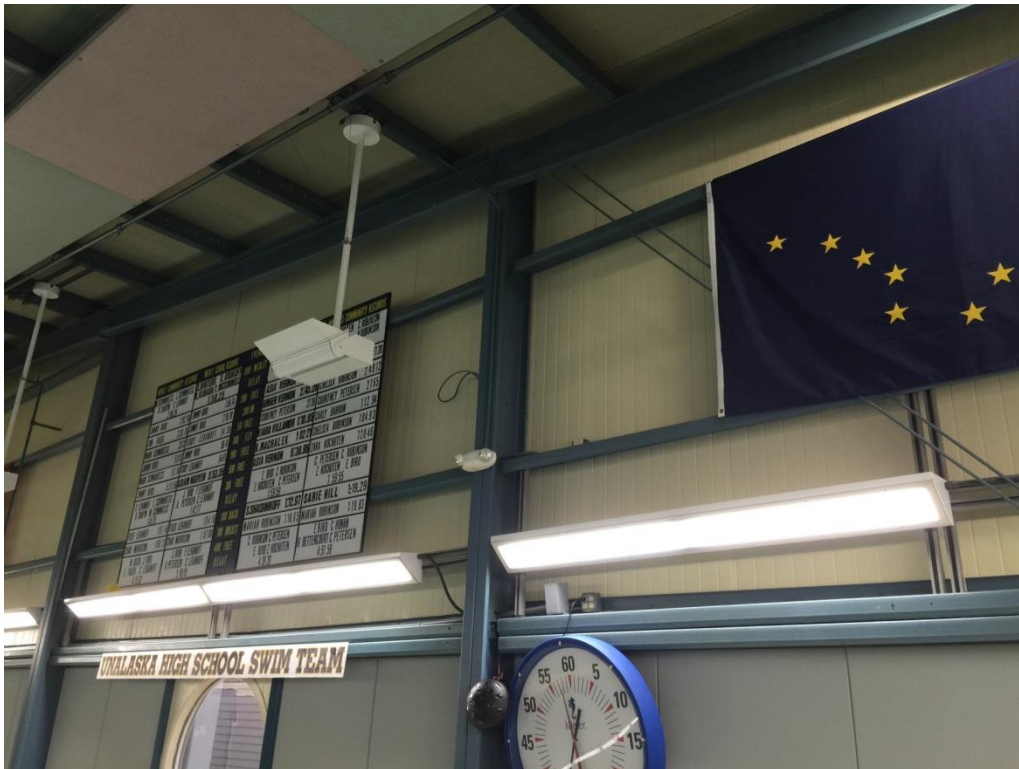
IMAGE 9.

NATATORIUM 121 - EAST WALL

REMOVE EXISTING WALL MOUNTED DISPLAY

INSTALL NEW ELECTRONIC TIMER IN THIS LOCATION

REMOVE EXISTING START BLOCKS
1.) GROUT EXISTING HOLES SOLID - RESURFACE WITH ACRYLIC CEMENTITIOUS DECKING, MATCHING SURROUNDING SURFACE (BASE BID)
2.) CORE DRILL AND INSTALL NEW STARTING BLOCK, RESURFACE WITH ACRYLIC CEMENT DECKING MATERIAL (BASE BID)

INSTALL NEW START BLOCKS.

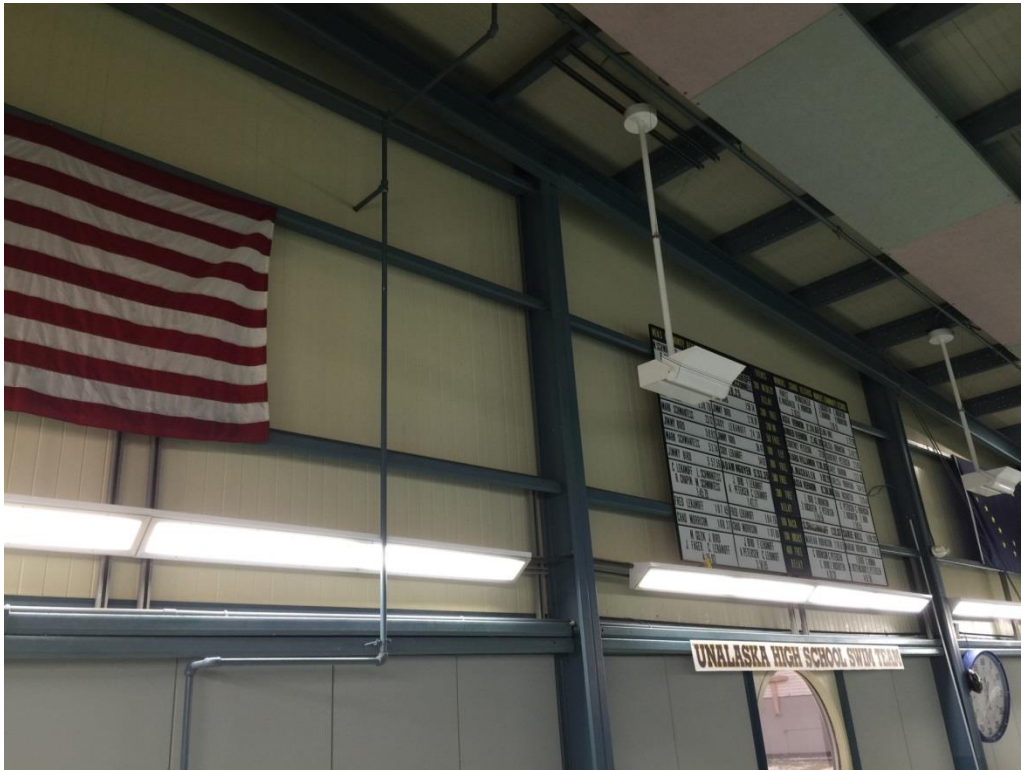
IMAGE 10.

NATATORIUM 121 - EAST WALL
