Geotechnical Engineering Report Unalaska Library Improvements

> PND No. 181140 July 2019

UNALASKA LIBRARY IMPROVEMENTS Geotechnical Report

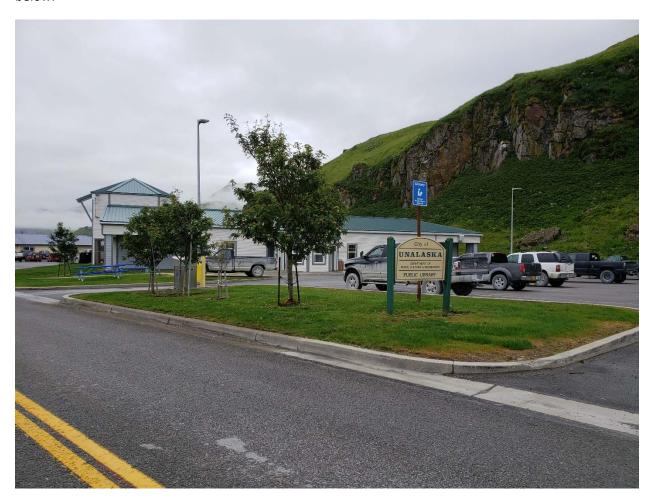
Figure 2-2. Site Surface Overview Photo

The front (west) side of the Library building consists on an asphalt pavement surface parking lot, concrete landing area, and landscaping features including drainage swales. The front side of the building is generally sloped from west-to-east with average slopes of 1 to 4 percent. The north side of the Library building consists of a seeded area which is sloped to drain away from the building towards Eleanor Drive. The rear (east) side of the Library building consists of a gravel surfaced parking lot and is generally sloped towards the east towards a drainage swale at the east end of the parking lot. The south side of the building consists of varying seeded and tundra vegetation. The south side of the Library building is also located immediately adjacent to a steep rock-faced cliff formation which rises approximately 40 to 50 feet above the building floor elevation. A site surface overview photo, looking southeast, is included for reference in Figure 2-2 below.

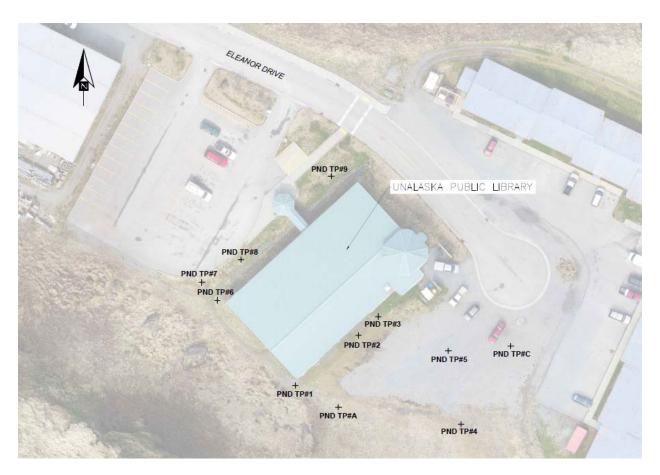
Figure 3-1. As-Built Borehole Locations

A total of 11 test pits were excavated during the geotechnical investigation. As-built borehole locations are shown on the map below.

3.1 As-Built Borehole Locations

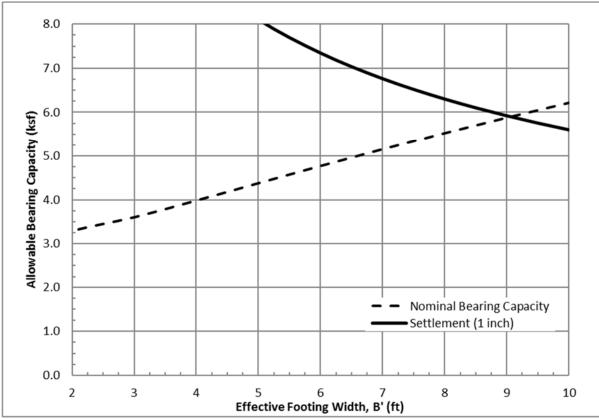
Figure 4-1. Allowable Bearing Capacity for Continuous Footings (based on AASHTO 10.6.3)

The allowable bearing capacity for the strip footings can be determined from Figure 4-1 for different footing widths. The solid line represents the bearing capacity where 1 inch of settlement occurs under the footing.

o Static Loads (Dead and Normal Live): See Figure 4-1

The allowable bearing capacity for the proposed spread footings should be assumed to be 4,000 psf.

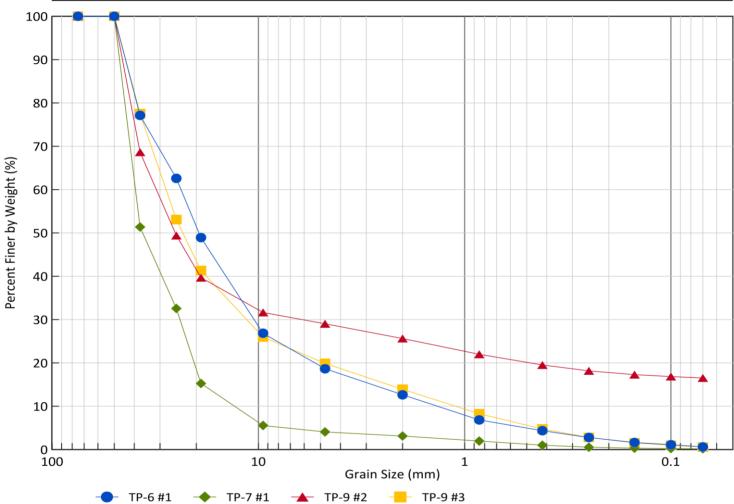
Sample				Gra	dation ((%)		
Borehole	#	From	То	Laboratory Classification	Gravel Sand Fines 81.3 18.0 0.0 95.9 3.9 0.0	Fines	D50	P10	
TP-6	1	1.5	2	GPs	81.3	18.0	0.0	19.4	12.7
TP-7	1	4.5	5	GP	95.9	3.9	0.0	36.4	3.1
TP-9	2	2.5	3.5	GM	71.0	12.5	16.0	25.3	25.6
TP-9	3	5.5	6.5	GPs	80.1	19.3	0.0	23.3	13.9

Gradation curves are located in Appendix B.
