CITY MANAGER'S REPORT

RE: Slope Scaling Site Observation and Mitigation Alternatives - DRAFT
Port of Dutch Harbor, Latitude 54 Building, Unalaska, Alaska

SLOPE SCALING - SITE OBSERVATIONS

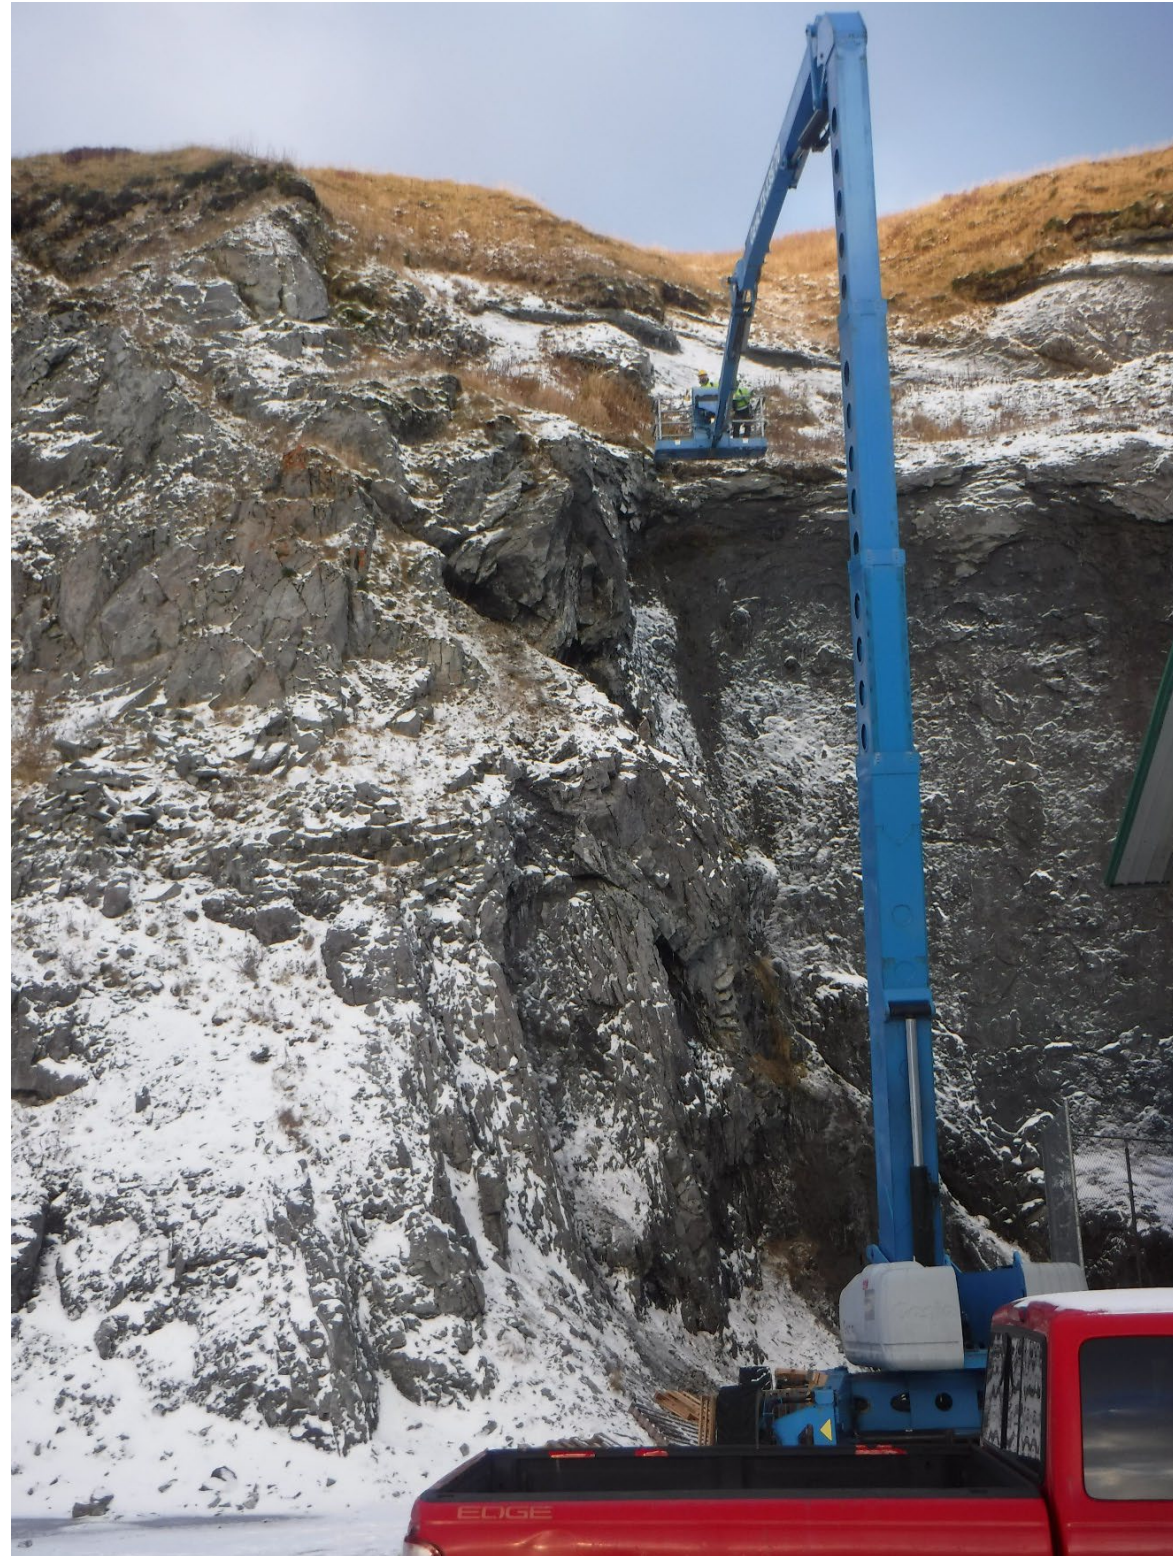
Photo 1

Description: Day 1 Scaling Operations at WU 1a Via Manlift
Photo Date: Dec 05, 2023

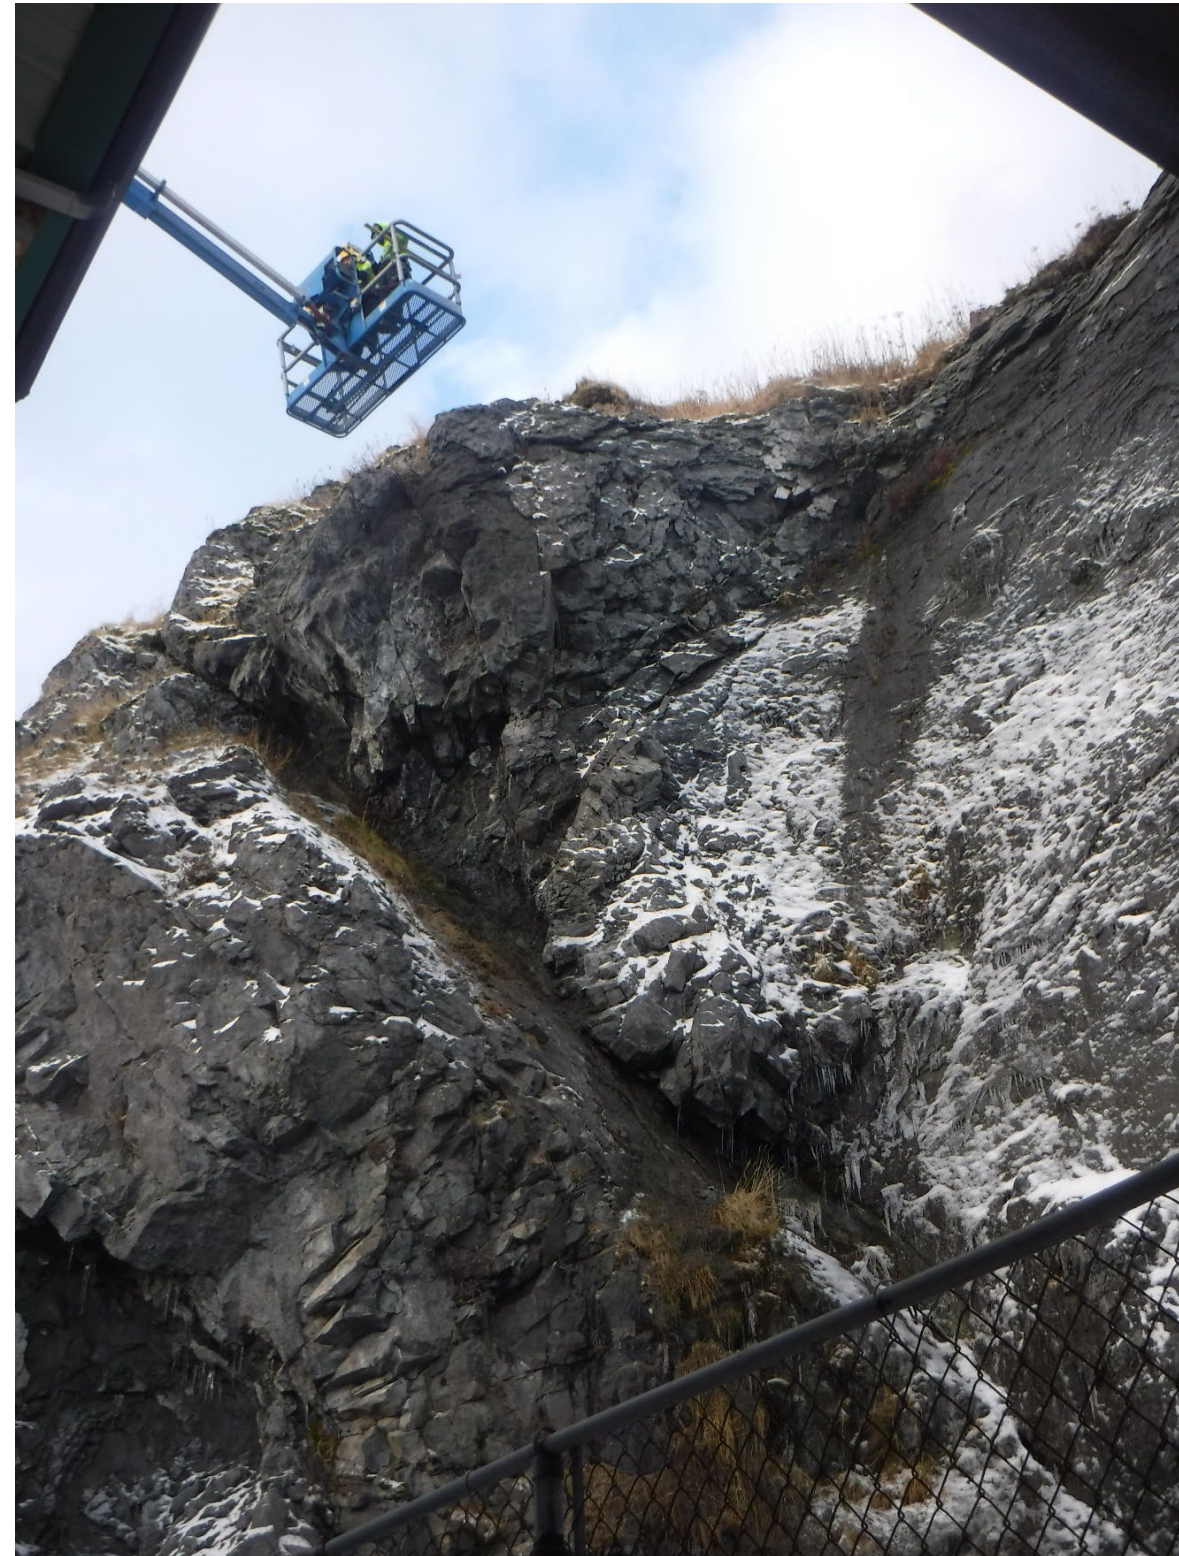
Photo 2

Description: Day 1 Scaling Operations at WU 1a Via Manlift
Photo Date: Dec 05, 2023

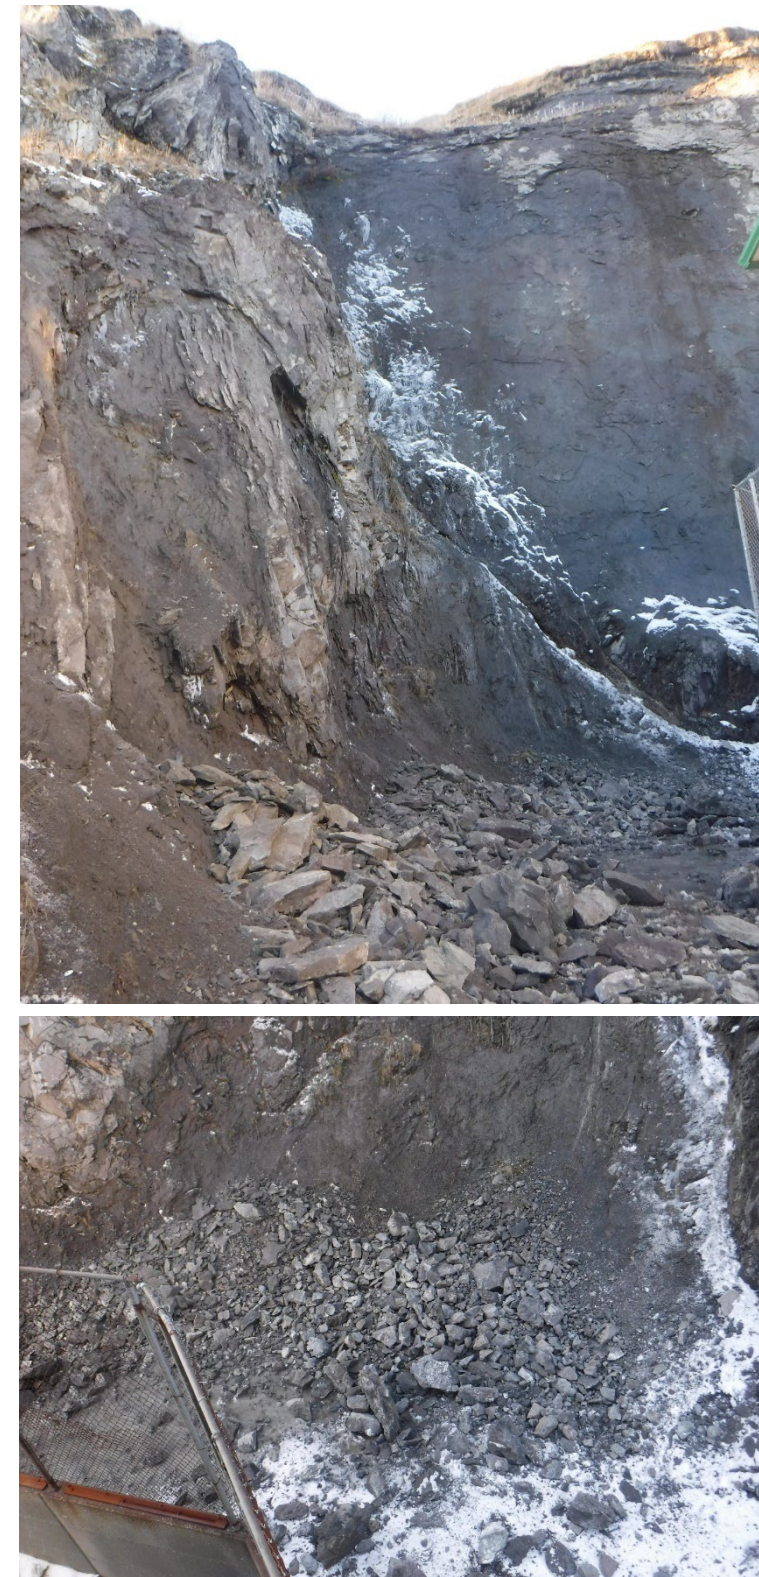
Photos 4a & 4b

Description: Scaling Progress and Accumulations of Rocks Scaled Off the Face (WU 1a, CSL) After Day 1.
Photo Date: Dec 05, 2023

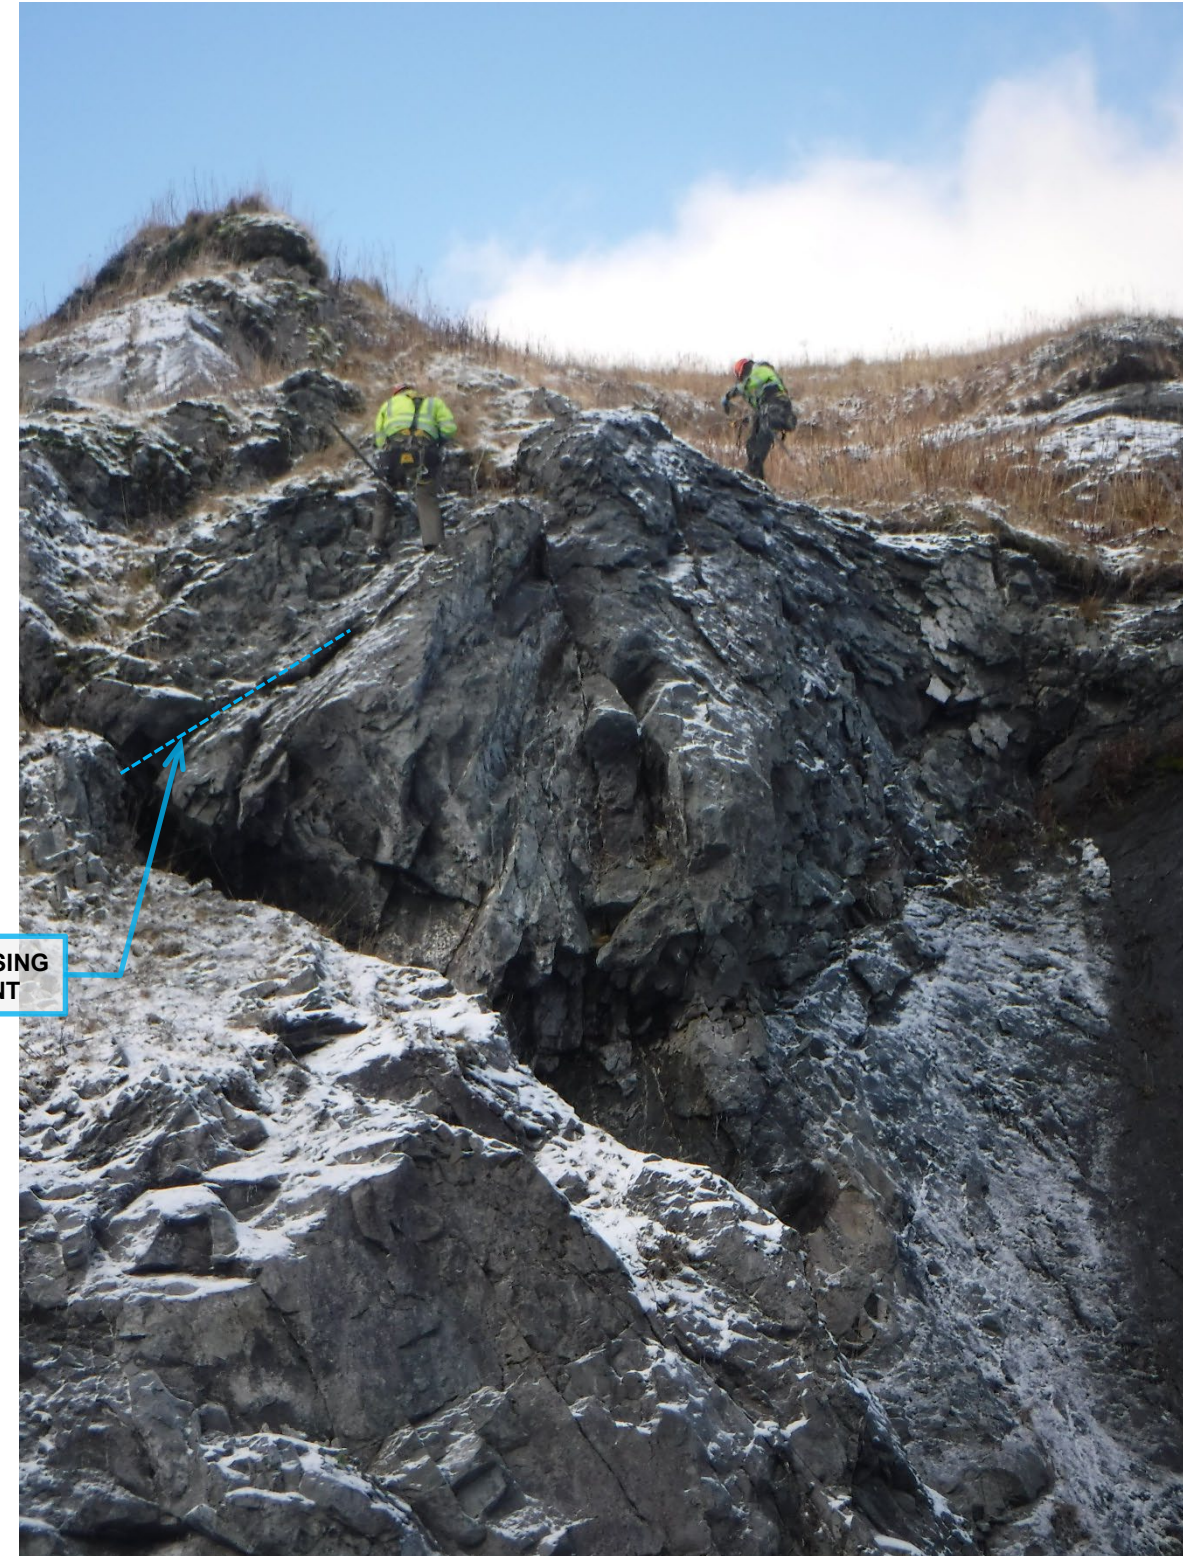
Photo 6

feature of this joint is that it strikes in an opposing direction normal to the primary sill joint (which serves as base for the wedge, as shown in **Photos 5, 6, and 8, Appendix A**). The continuity of this joint into the slope is unknown; however, in a scenario where this opposing joint continues further across the wedge and/or into the hillside, the joint could create a discontinuity boundary to which the lower third of the upper wedge dislodges independent of the wedge above. The susceptibility of this rockfall at the lower third of the Upper Wedge is viewed as the greatest hazard remaining and should be priority for mitigation.

Description: Scaling Progress Upper Wedge
Photo Date: Dec 07, 2023

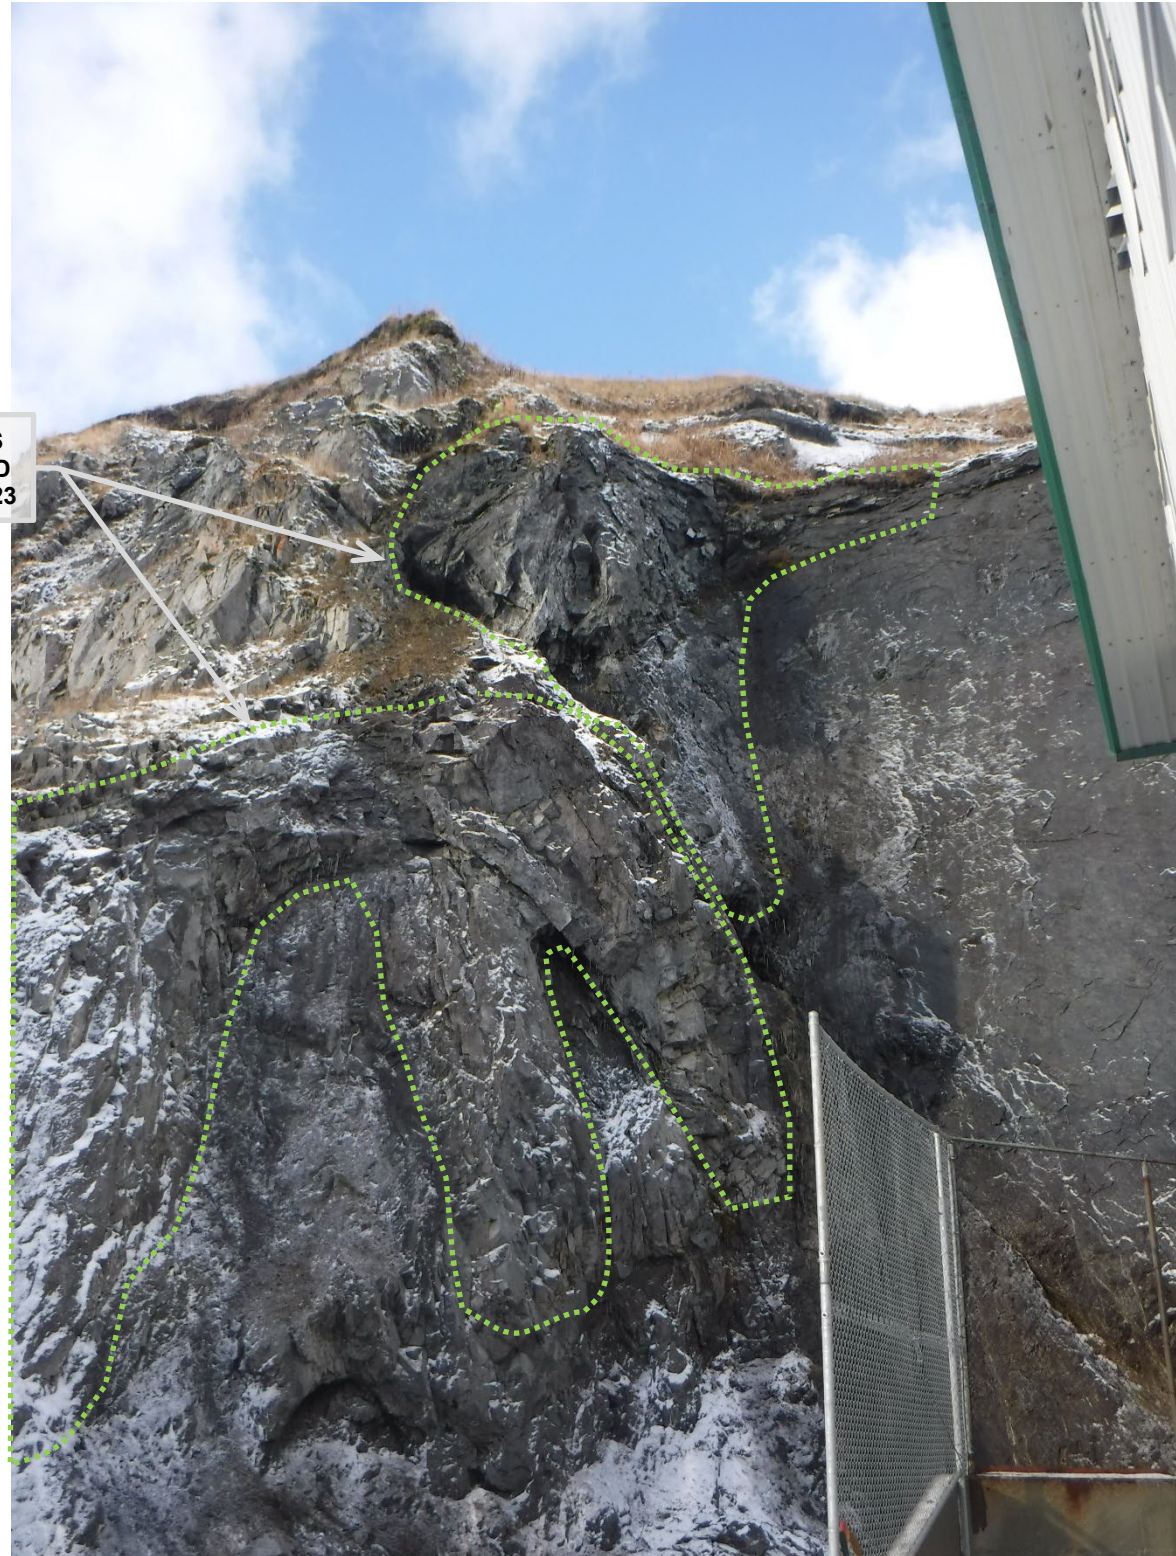
Photo 7

Scaling of the rock slope was performed by Southeast Roadbuilders between the dates of 04 to 07 December 2023. Scaling was accomplished by hand-operated tooling including pry bars. Scaling initiated in the upper portion of the wedge (identified as WU 1a)¹ and also included its upper corner with the existing backwall cut and the lower portion of the wedge (WL). Scaling was accomplished with the assistance of a 135-foot-reach manlift (see **Photos 1 through 4, Appendix A**). Some portions of the upper wedge were not entirely reachable with the manlift. After the reach to the upper wedge was exhausted, scaling from the man lift transitioned to areas at the left side of the cut slope (identified as CSL). Accumulations of rock fragments that were scaled off the face are noted at the base of the slope shown in **Photos 3 and 4**. Scaling activities then switched to roped-access from above the slope and focused on the upper portion of the wedge (WU 1a), as shown in **Photos 5, 6, and 10**. An outline of the areas where scaling was completed and conditions of the slope at the end of scaling activities are shown in **Photos 7 through 10**.

Description: Condition and Outline of Completed Scaling
Photo Date: Dec 07, 2023

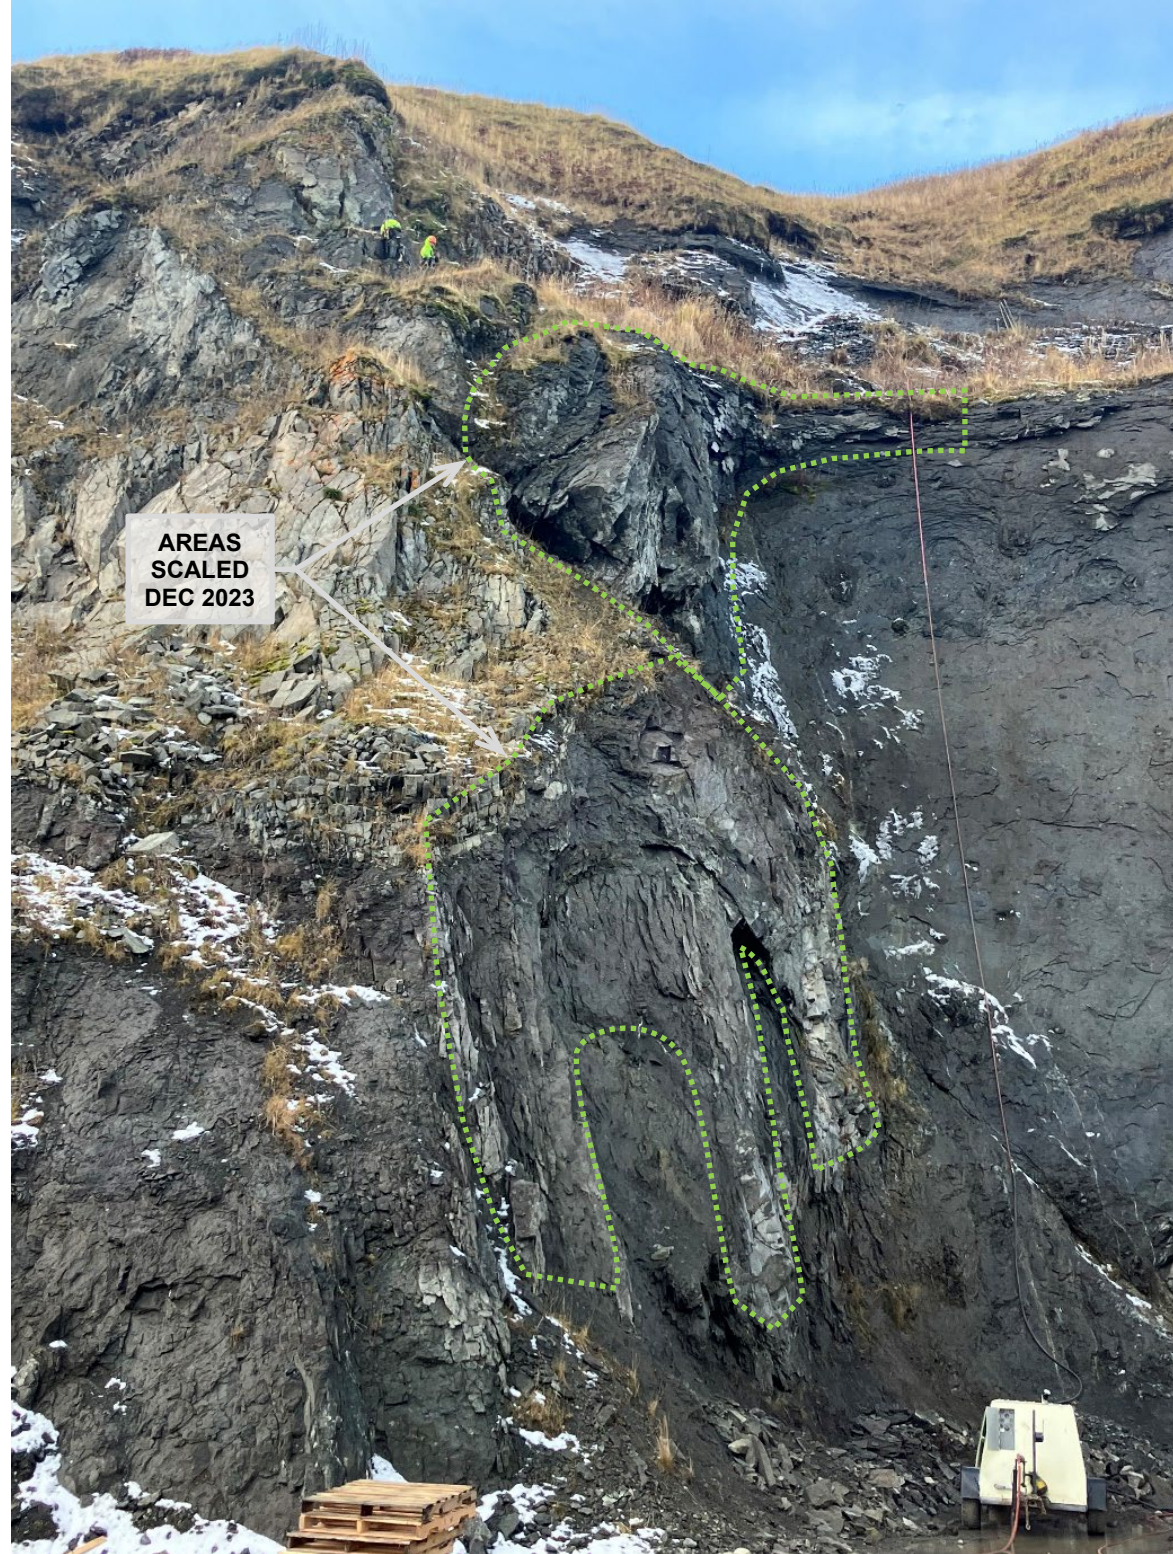
Photo 9

Description: Condition and Outline of Completed Scaling
Photo Date: Dec 06, 2023

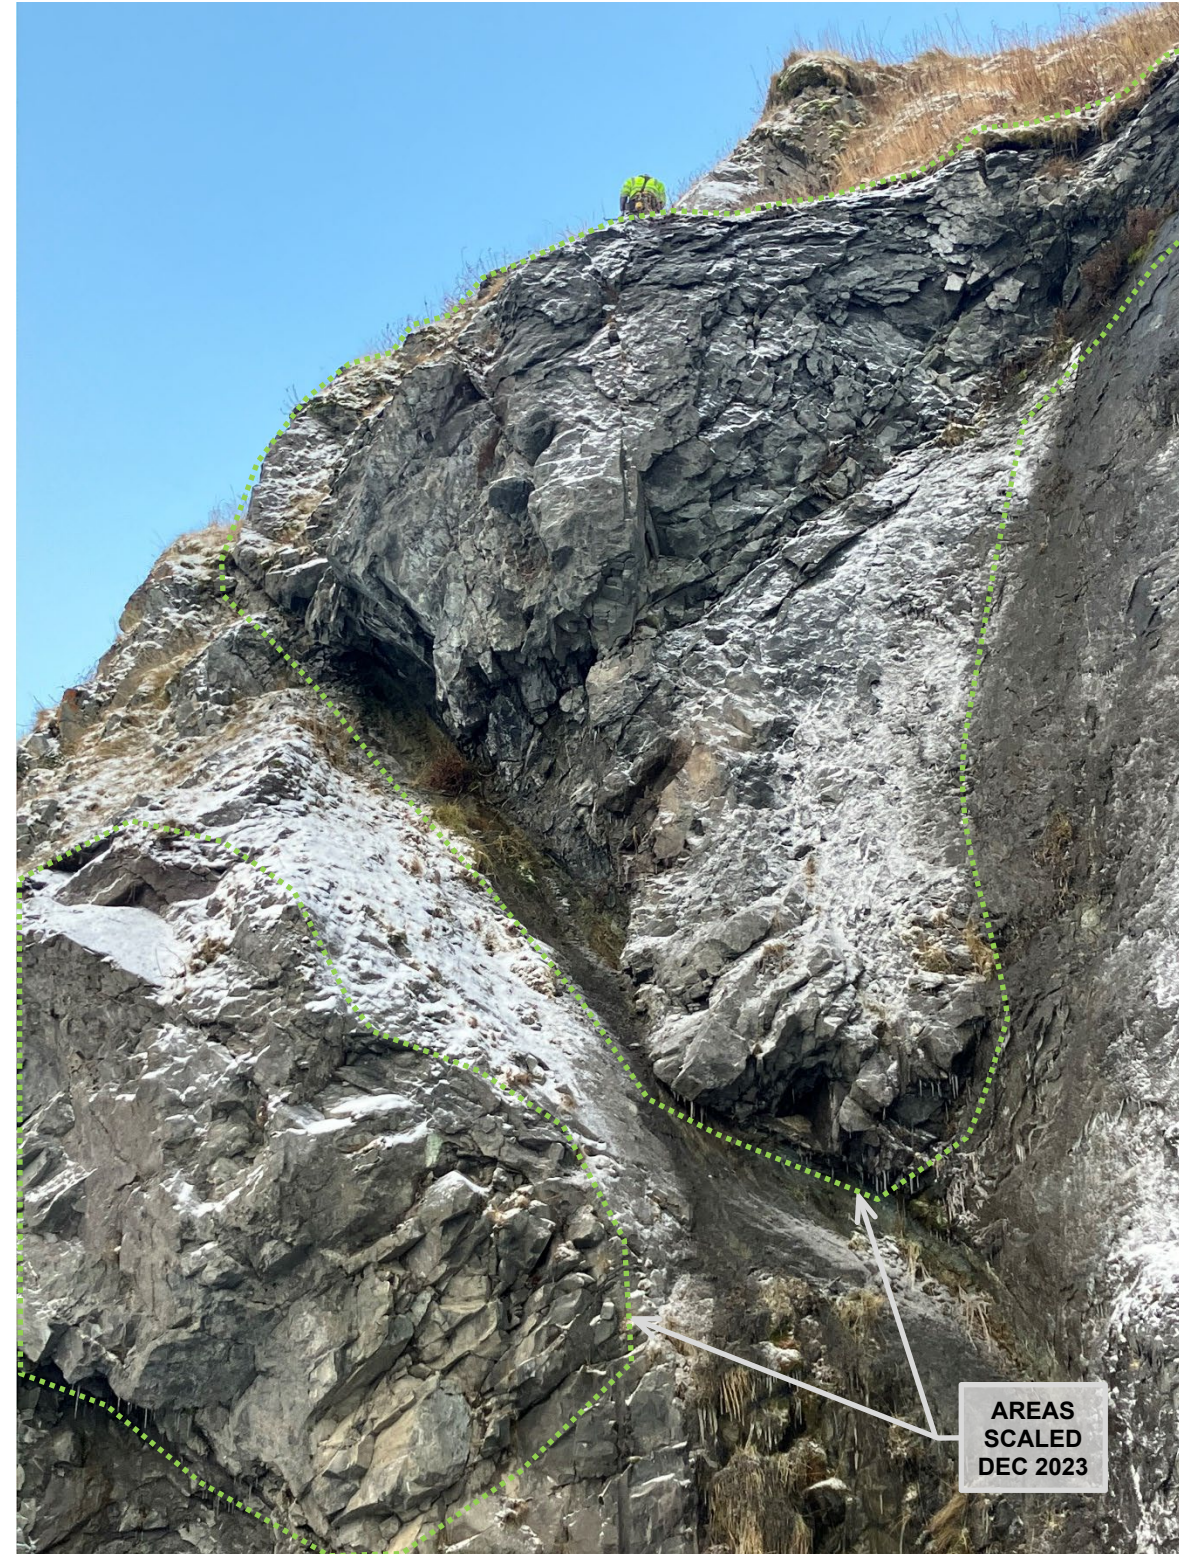
Photo 10

Description: Condition and Outline of Completed Scaling
Photo Date: Dec 07, 2023
